Preliminary Arboricultural Report

Arbor Analytics Australia

Tree Report - Preliminary Arboricultural Report (PAR)

1 Fairway Crescent, Middle Ridge

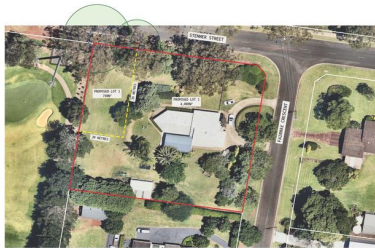
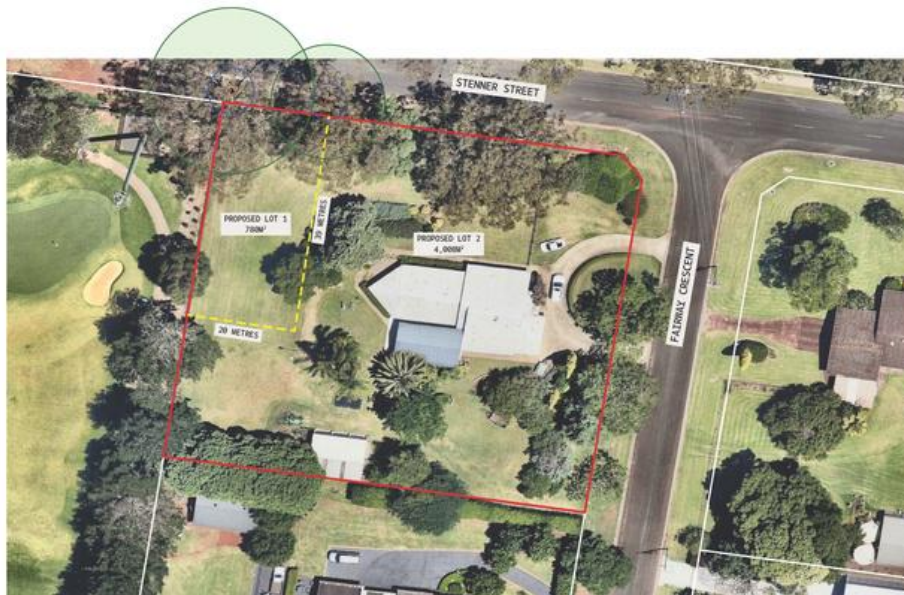
Photo 1

Aerial Map with NRZ & SRZ Specification

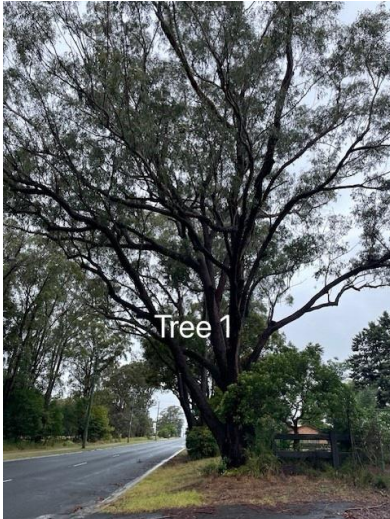
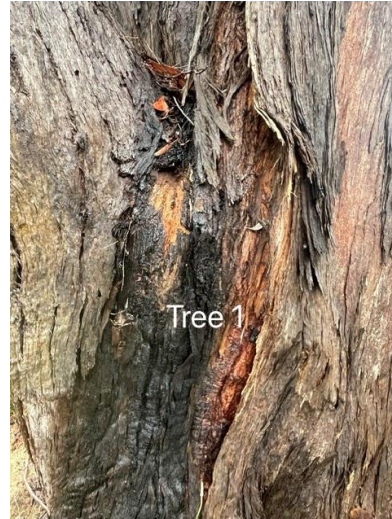
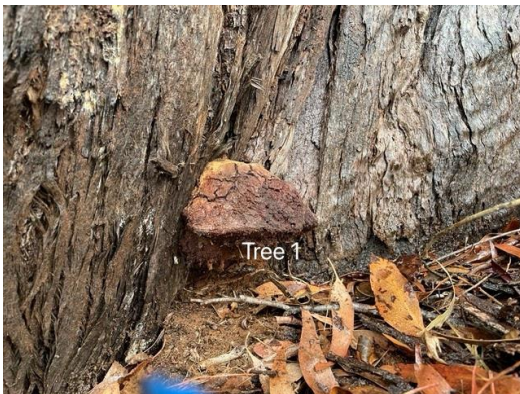
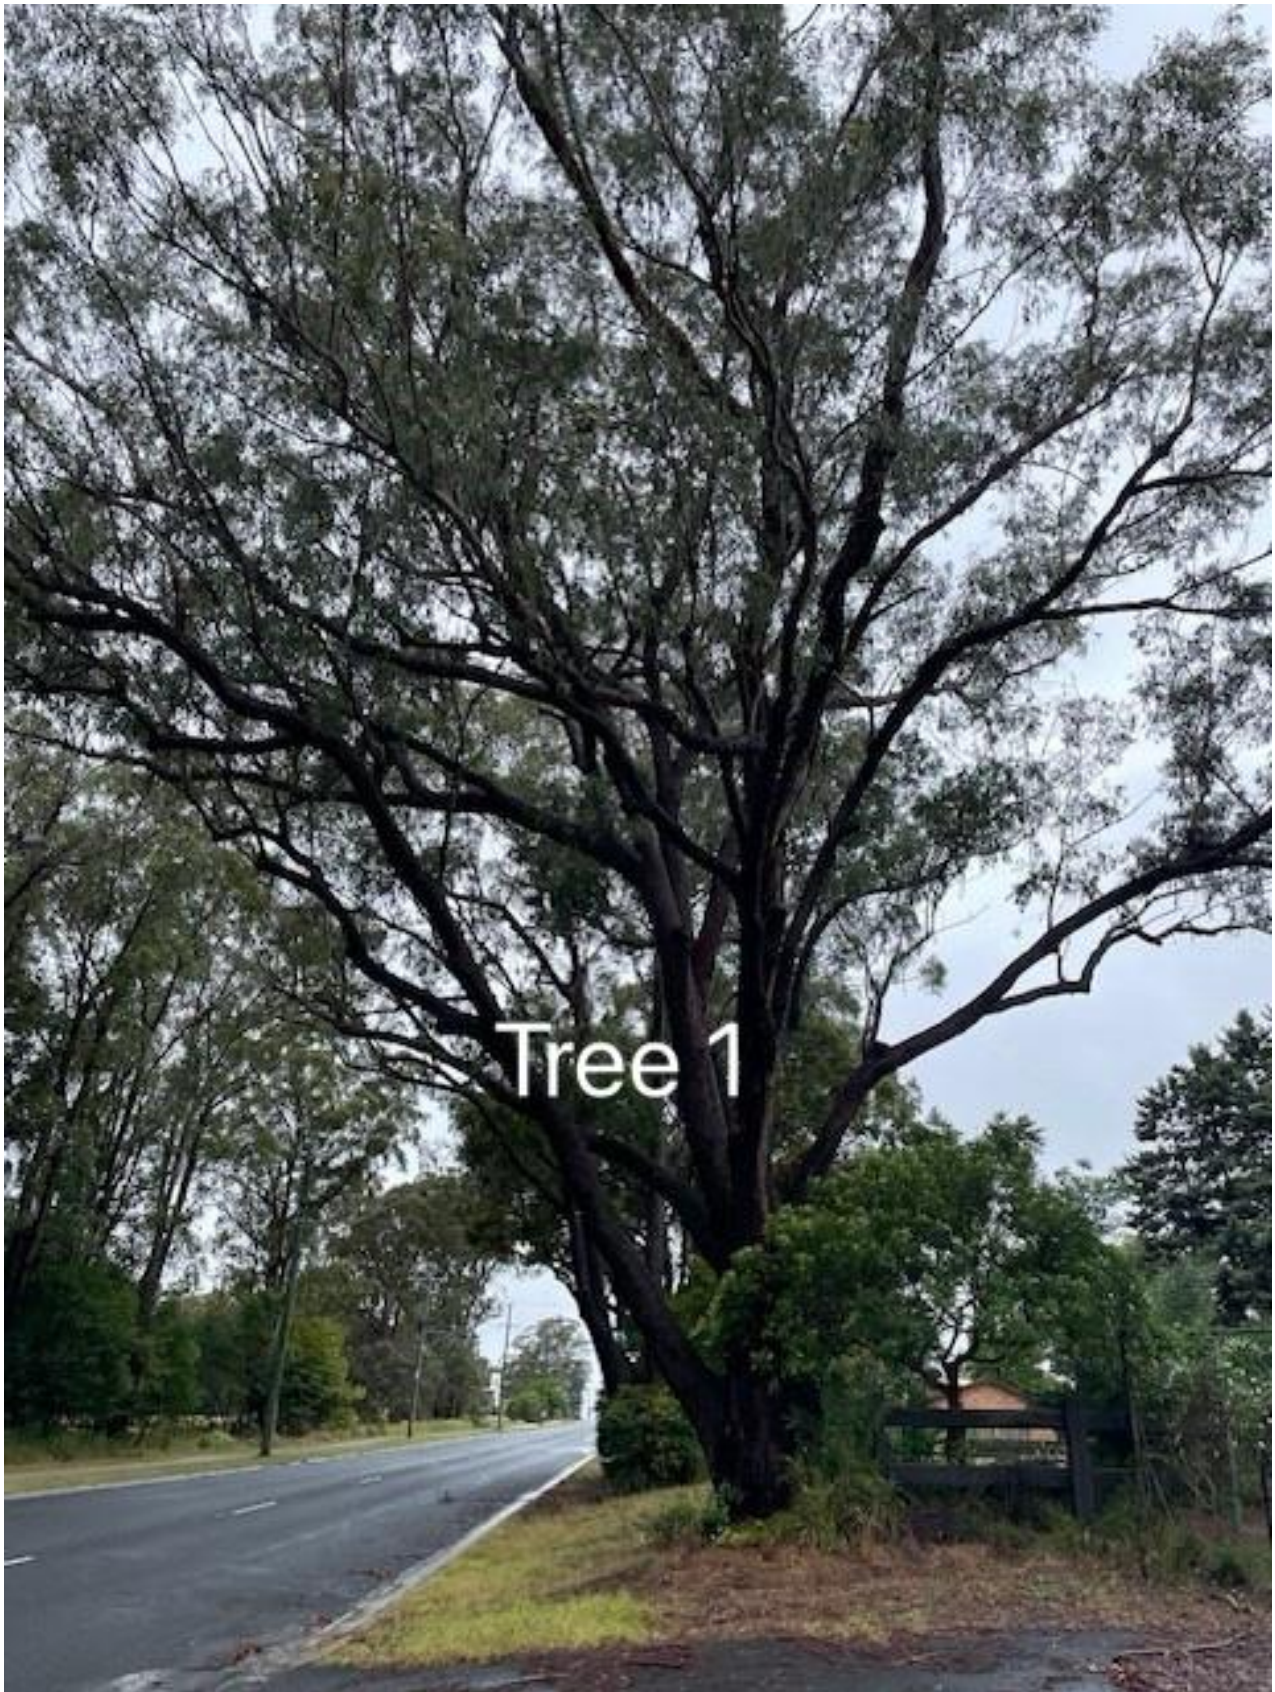
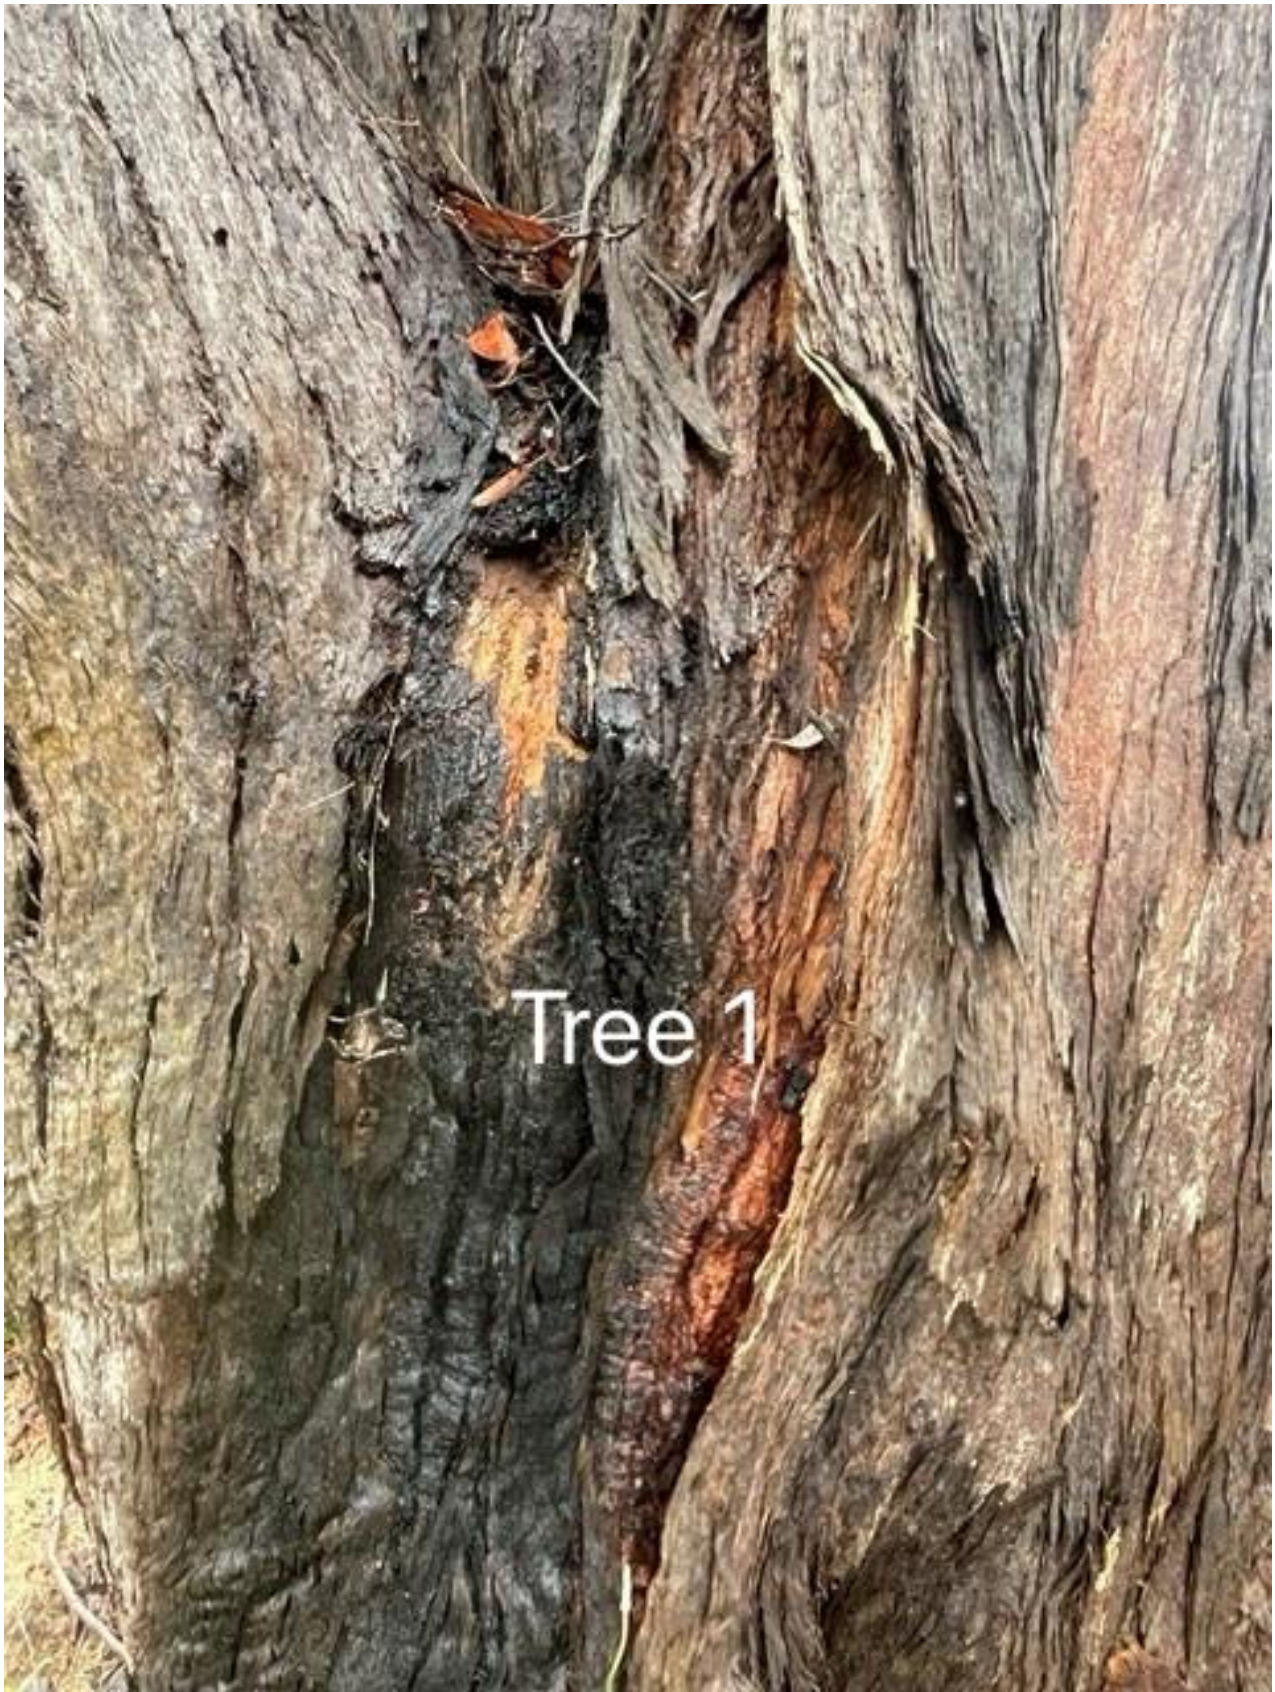
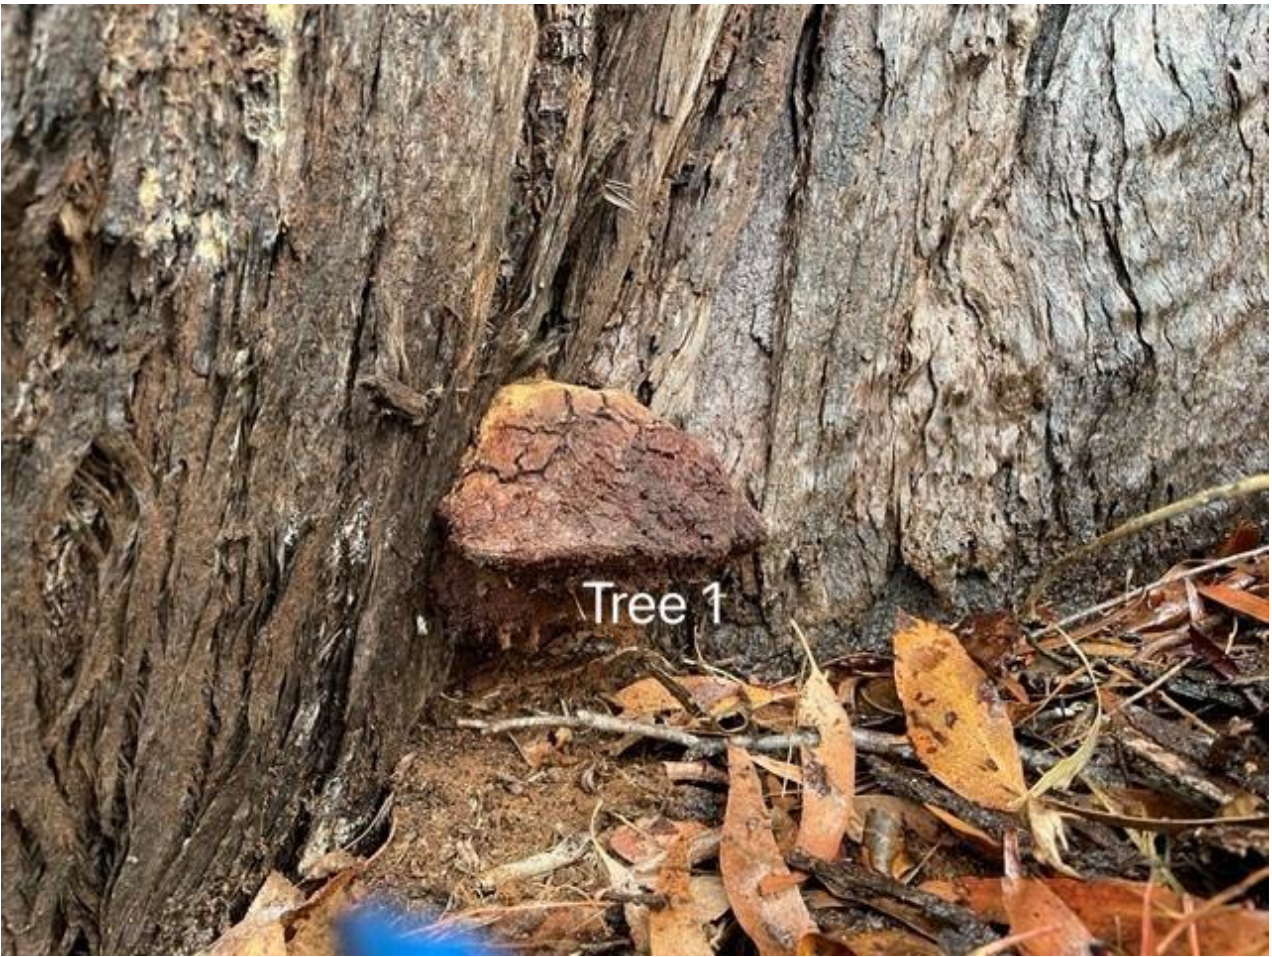
TREE 1

Botanic name (Common Name) Eucalyptus andrewsii (New England Blackbutt)

Structure Fair

Risk Rating 10 High - Failure likely especially during storms but low potential for injury/property damage

This tree is in good condition. It has an extensive canopy which spreads well over the roadway and into the nearby properties. The tree has some deadwood present in the crown and has been pruned in the past. There are some dead limb stubs present where incorrect past pruning methods were used. The tree is situated less than 1 metre from the private property at 1 Fairway Crescent (on the northwestern corner) but is located on the Council footpath and is 4 metres from the roadway. There has been an asphalt roadway recently installed 6 metres west of the tree inside the Tree Protection Zone (servicing the Telstra tower). The tree has a codominant limb structure close to the base that shows scarring and reactive tissue, this is a sign of instability. The tree has a fungal infection near the root crown, evidenced by the presence of a Ganoderma bracket fungal flower. The distance between Tree 1 and Tree 2 (the two trees identified in this Report) measured from the centre of the base of each tree (which is the same as the calculations for the TPZ and SRZ) is 16.8 metres.

Correctly prune limb stubs and a 15% weight reduction applied to the outer lower canopy that extends the roadway, footpath and the property. The tree should be monitored for changes in health and structure. There is a proposed entry way to be installed at a distance of 7.9 metres from the centre of the base of the tree (well outside the Structural Root Zone). This will be an encroachment into the TPZ of 18.1%. This encroachment is considered to be moderate and within the allowable 'moderate incursion' framework. Any excavation works inside the TPZ will require vacuum excavation to be completed at the edge of the works closest to the tree. Any roots located will require corrective pruning by a qualified Arborist. Excavation works should be carried out from the outside edges of the encroachment to minimise compaction.

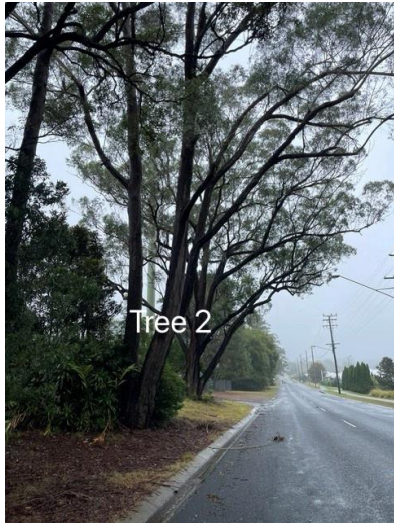
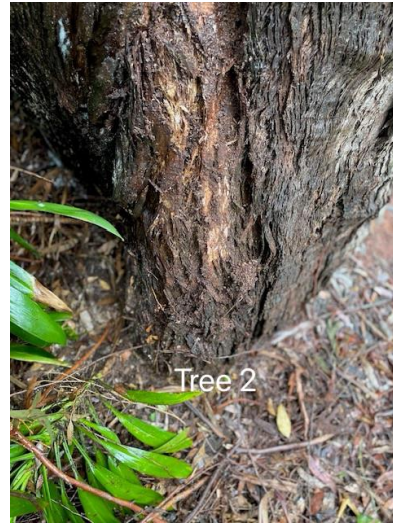
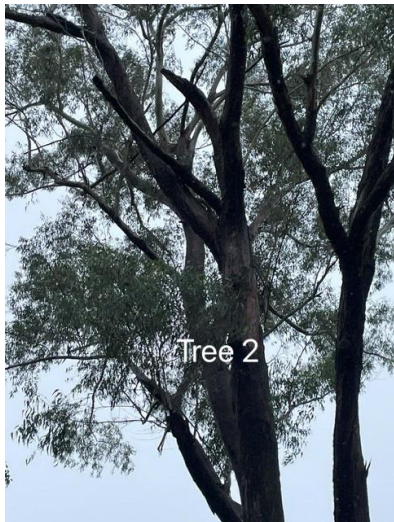
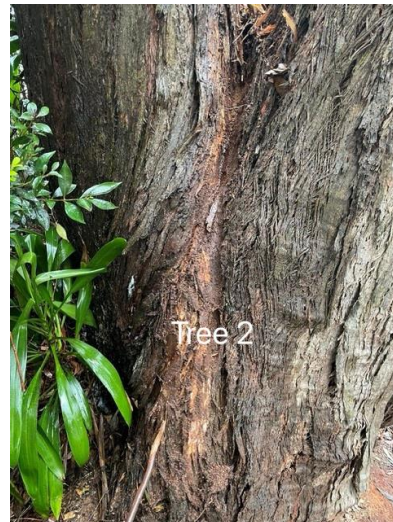
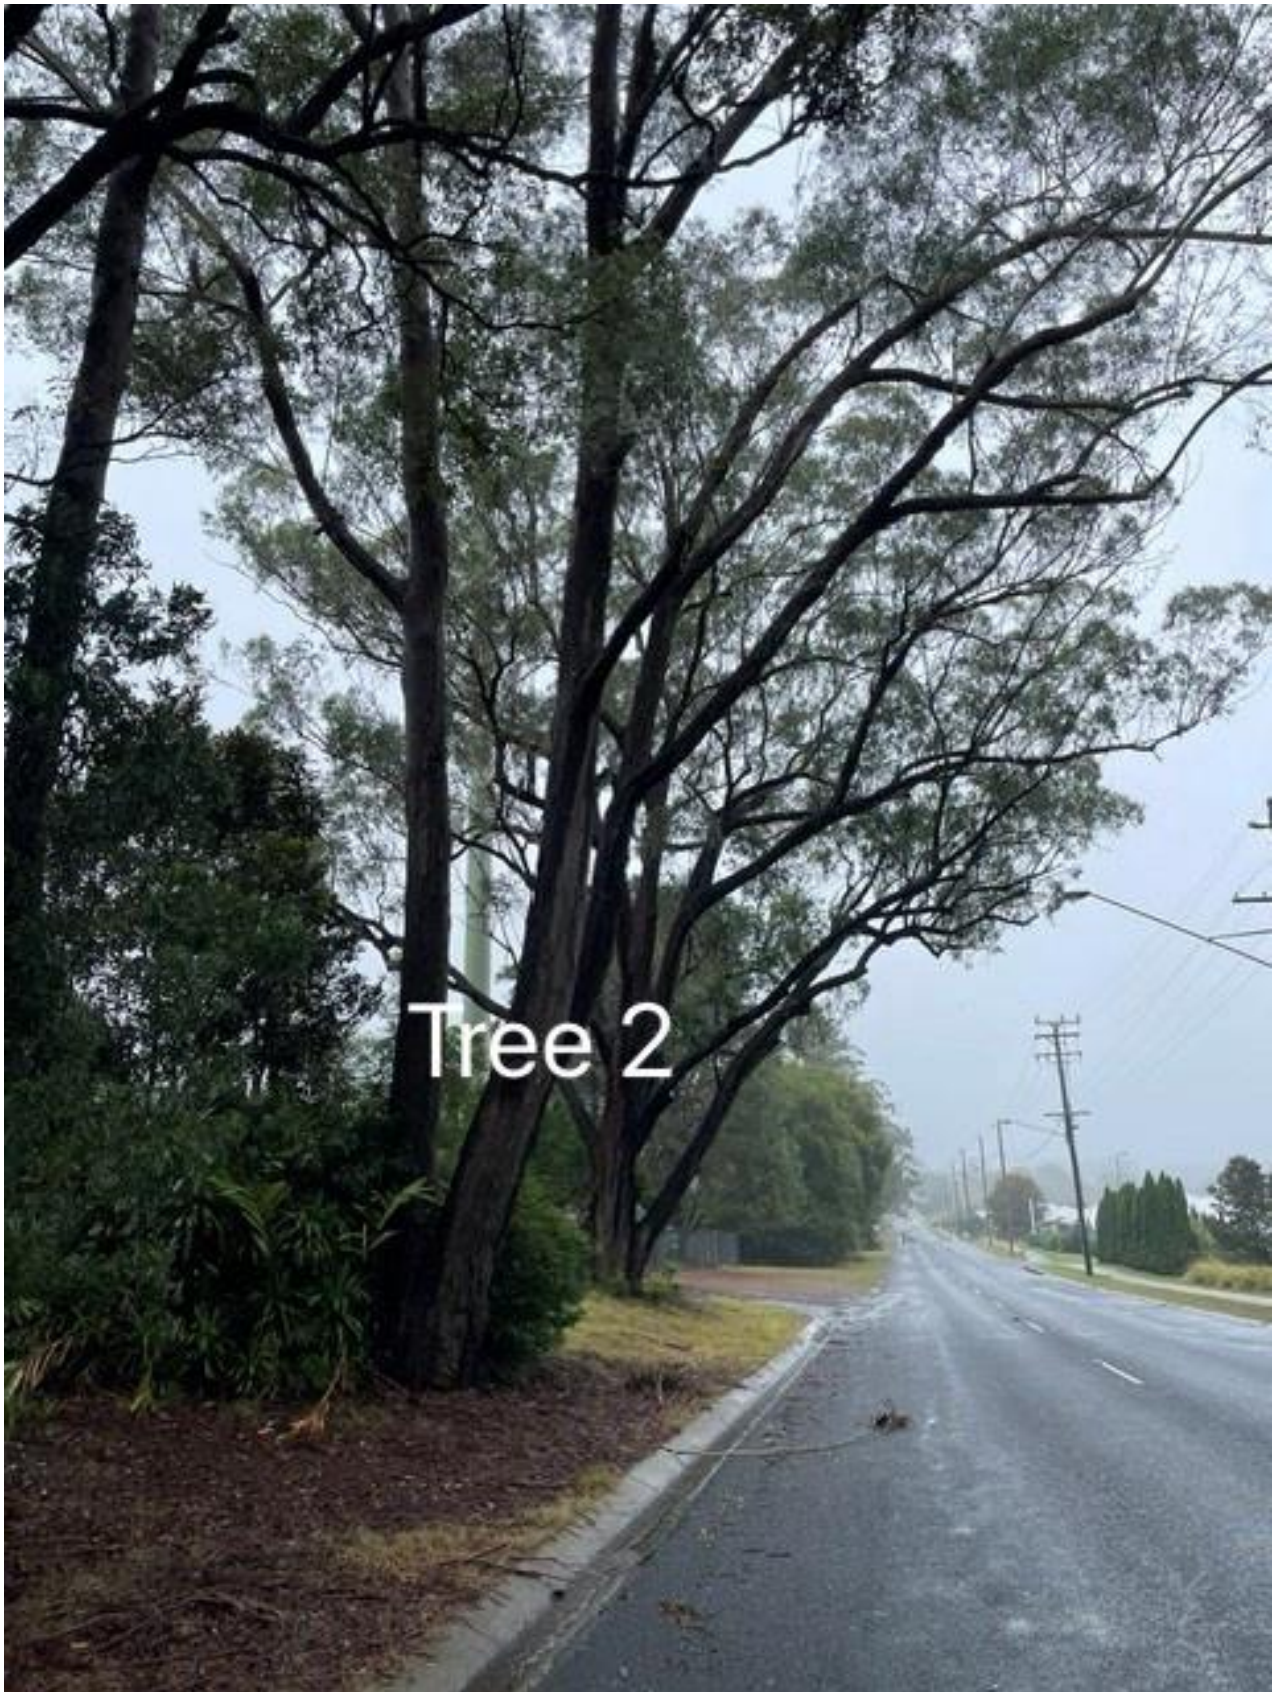
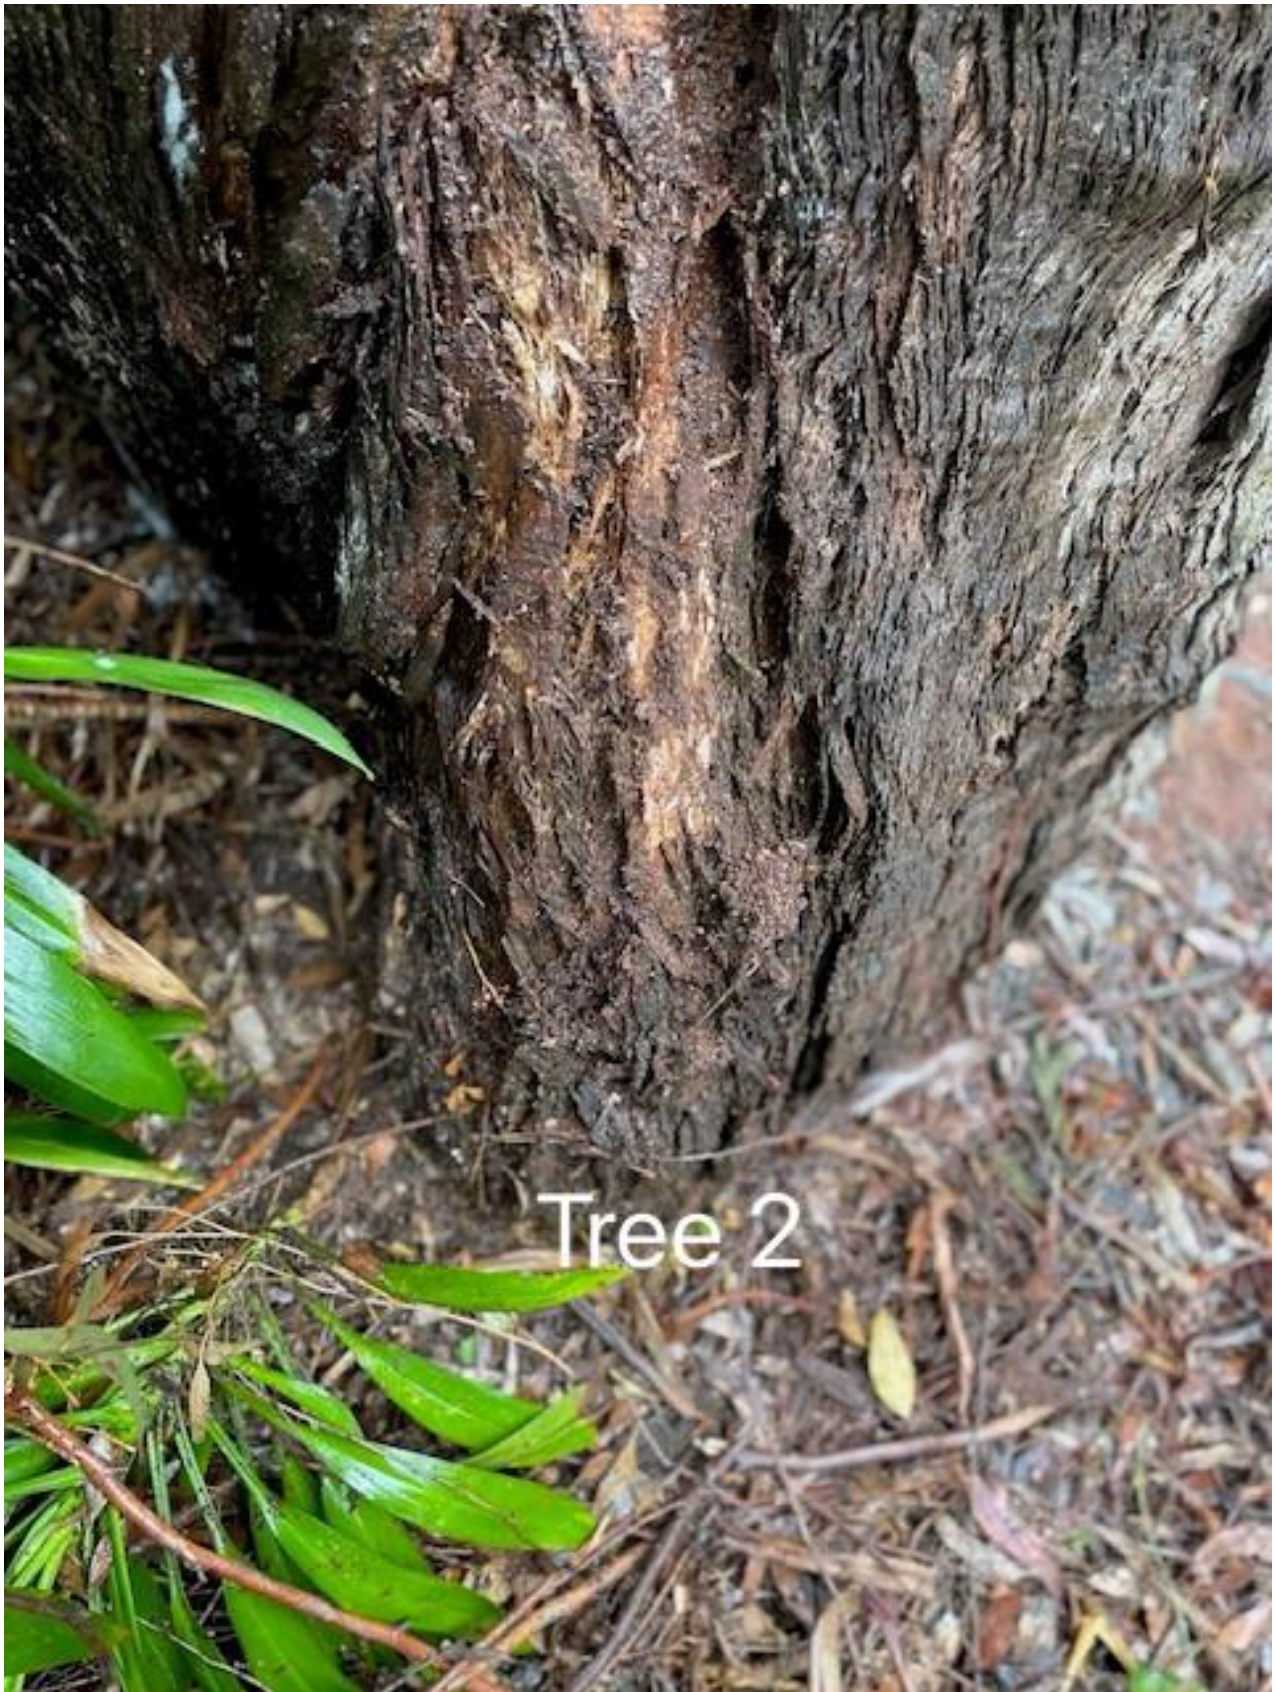
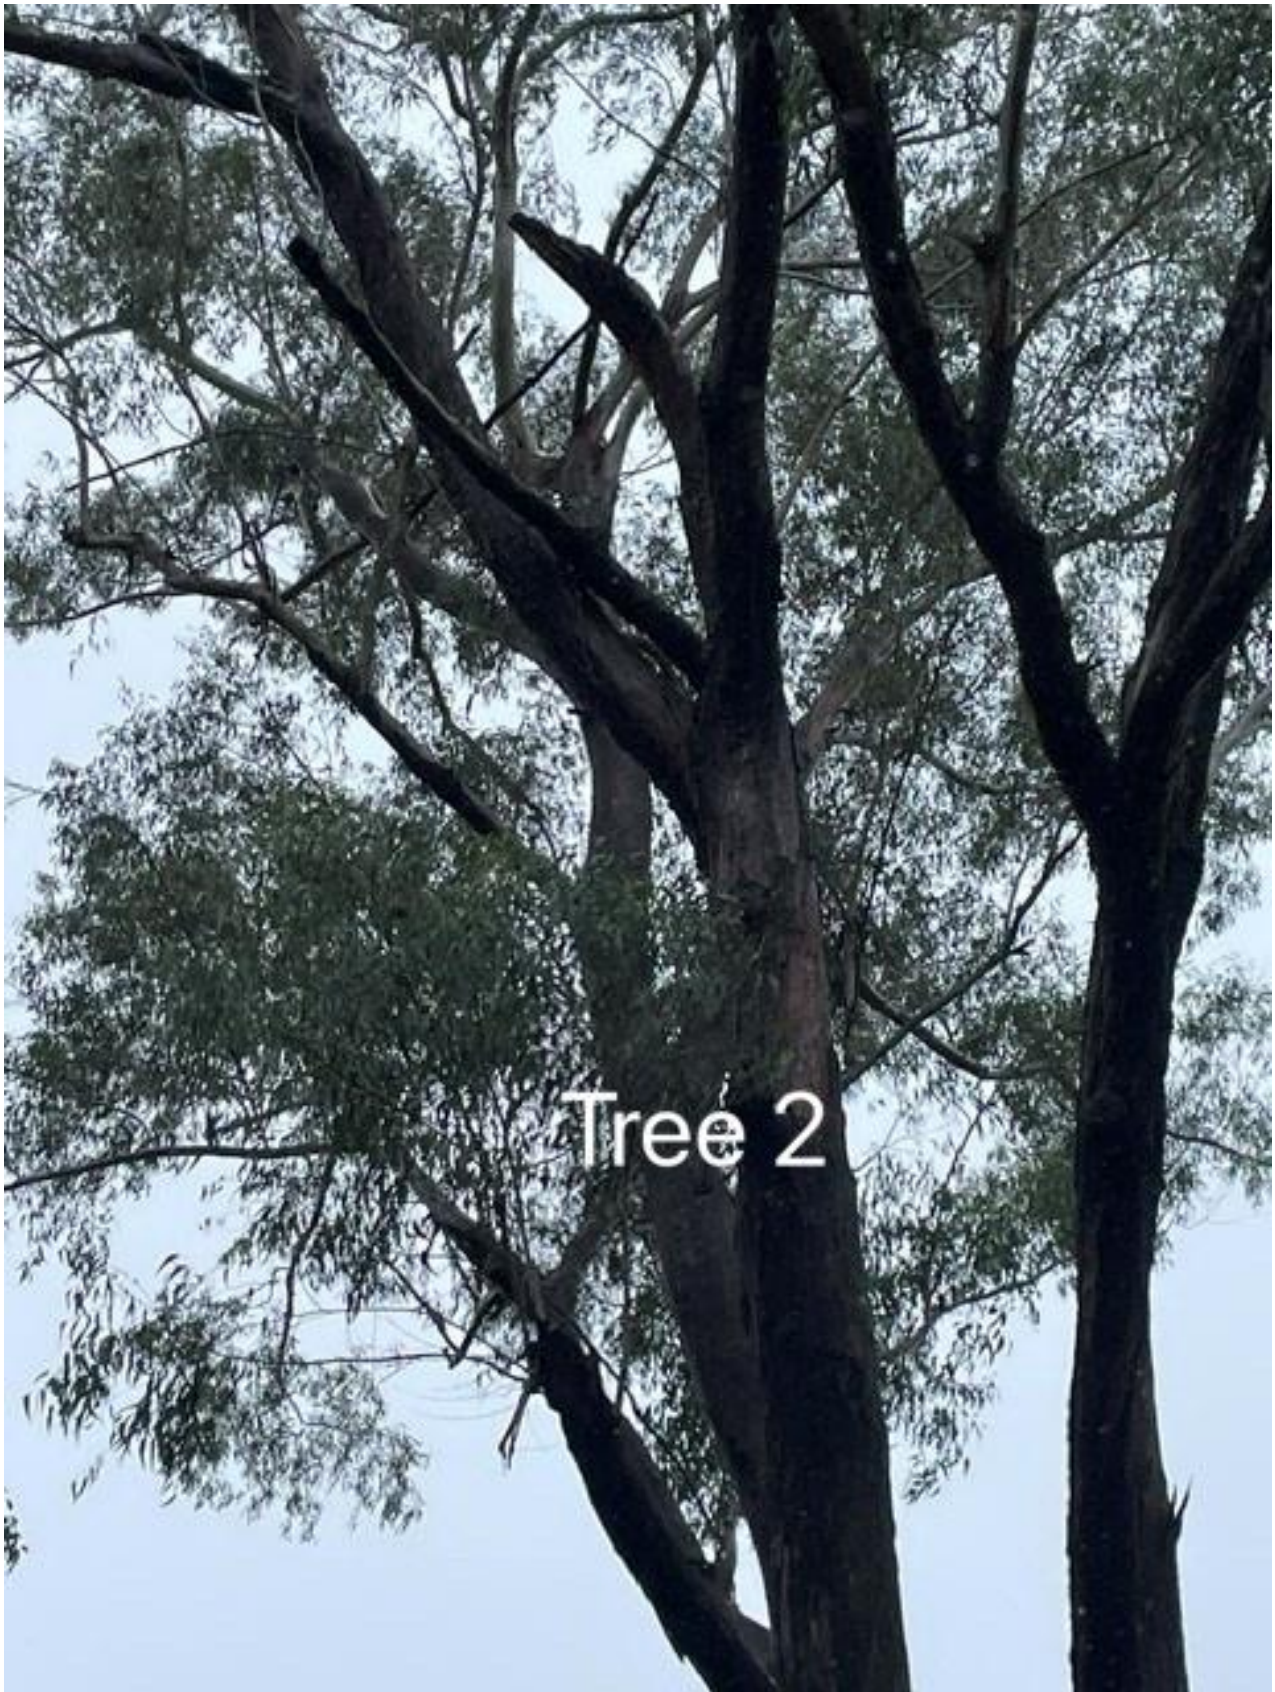
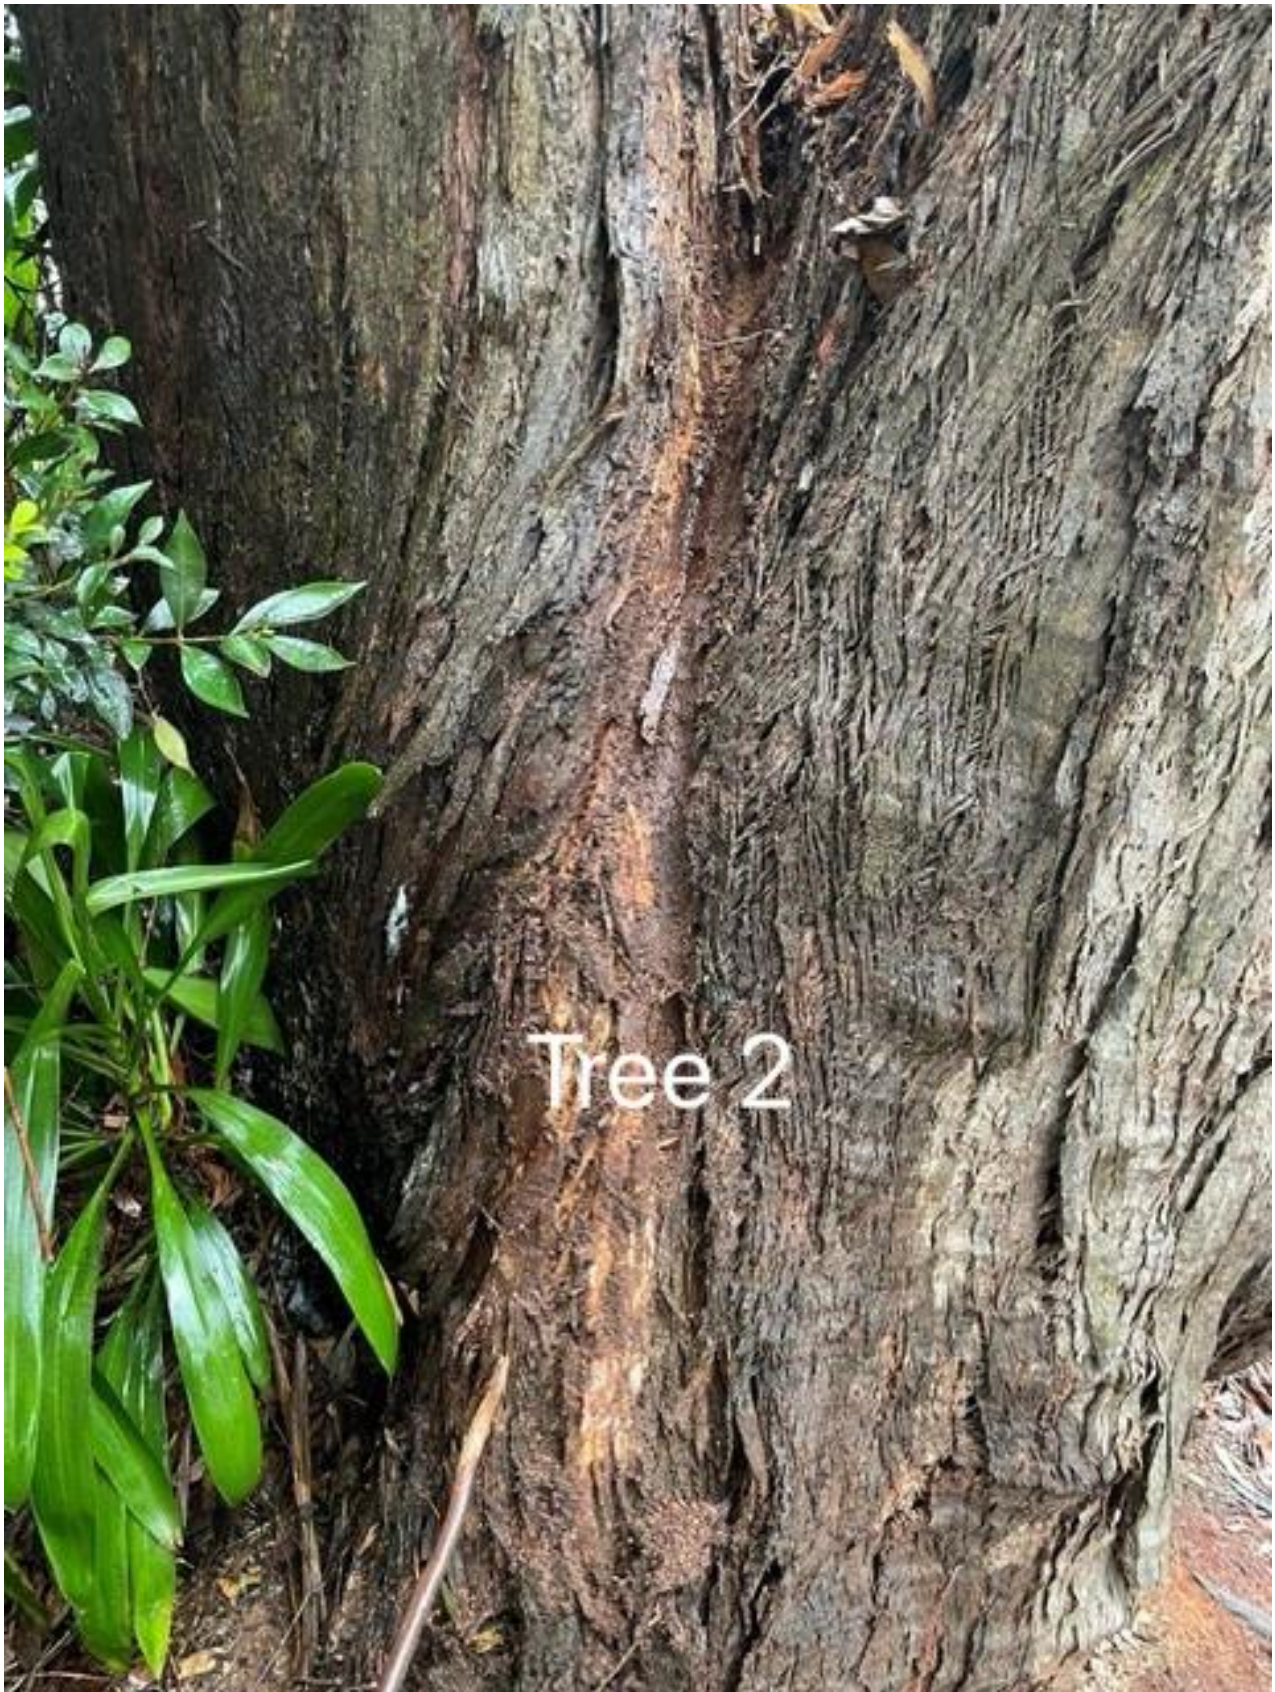
TREE 2	
Botanic name (Common Name)	Eucalyptus andrewsii (New England Blackbutt)
Trunk Diameter (DSH) (mm) & (DAB) (mm)	860 & 1000
Height (m)	25
Age	Mature
Health	Good
Structure	Fair
Safe Usual Life Expectancy (SULE)	2A - Trees which may live between 15-40 years - retainable at the time of assessment with an acceptable degree of risk, assuming reasonable maintenance
Canopy Spread (m)	17
Notional Root Zone (NRZ) (radius metres) (area square metres)	10.3 & 334.6
Structural Root Zone (SRZ) (radius metres) (area square metres)	3.3 & 34.4
Risk Rating	10 High - Failure likely especially during storms but low potential for injury/property damage
Heritage Search	✘ - Property is not listed on the Qld Heritage Register - the tree is less than 100-150 years old and there is no evidence of scarring
Retention Value	Medium - less critical but may be retained and protected

This tree is in good condition. It is situated 2.5 metres from the roadway and 2 metres from the private property at 1 Fairway Close and is located on the Council footpath. This tree has developed a significant lean to the north and over the roadway. The majority of the tree has developed on the northern side of the trunk due to its position and competition with nearby trees. There is significant excess weight present on the northern side and in the outer lower canopy. The tree has significant scarring and reactive tissue present on the eastern side at the base of the trunk at the site of the connection of two codominant trunks. There is included bark present in the trunk, this is a sign of instability. The tree has recently lost a significant leader from the crown, the broken limbs stub is approximately 15 metres from the ground.

Correctly prune broken leader stub. Remove any deadwood and apply a 20% weight reduction to the outer northern canopy. The tree should be monitored for changes in health and structure. There is a proposed entry way to be installed at a distance of 5.4 metres from the centre of the base of the tree (well outside the Structural Root Zone). This will be an encroachment into the TPZ of 18.3%. This encroachment is considered to be moderate and within the allowable 'moderate incursion' framework. Any excavation works inside the TPZ will require vacuum excavation to be completed at the edge of the works closest to the tree. Any roots

located will require corrective pruning by a qualified Arborist. Excavation works should be carried out from the outside edges of the encroachment to minimise compaction.
