REPORT TITLE	Development Application – Preliminary Approval – Building Work (Planning Scheme Works) – Demolition of Neighbourhood Character Dwelling located at 68 Hume Street, NORTH TOOWOOMBA QLD 4350
AUTHOR	Senior Planner (Geoff Broadbent)
Application No.	PSW/2020/5933

To consider a Development Application for a Preliminary Approval for Building Work (Planning Scheme Works) – Demolition of Neighbourhood Character Dwelling located at 68 Hume Street, NORTH TOOWOOMBA QLD 4350.

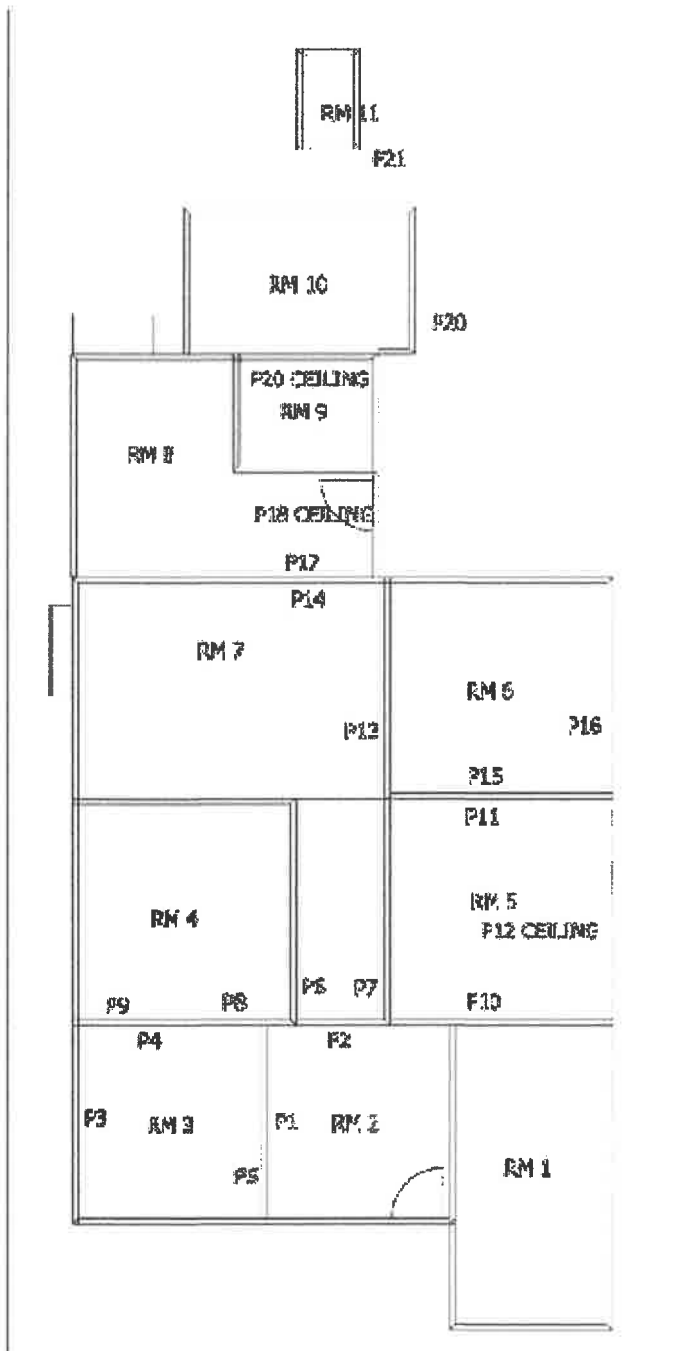
**APPENDIX A – PHOTOGRAPH LOCATION PLAN**

Typical of termite damage in VJ boarding, some boards were completely hollowed out while adjacent boards were untouched therefore reference should be made to the photograph location plan and the photographs in Appendices A and B respectively to show the extents.

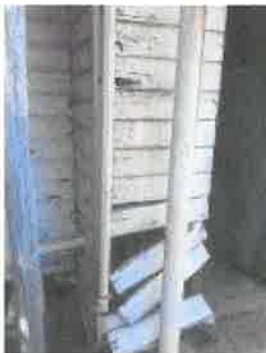
**Location - Decay throughout timber piers, internally, flooring, shed and laundry.**

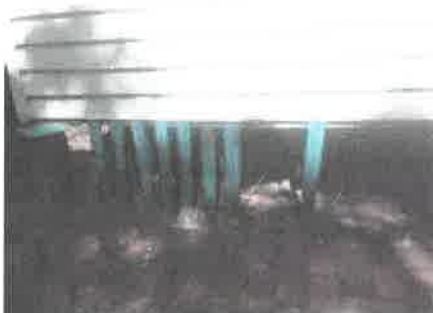
Was evidence of untreated or non-durable timber used in a hazardous environment found? **Yes - see Details below, Clauses A.7 and A.8**

**Trellis/Fences - Separate slats from ground and base of home.**

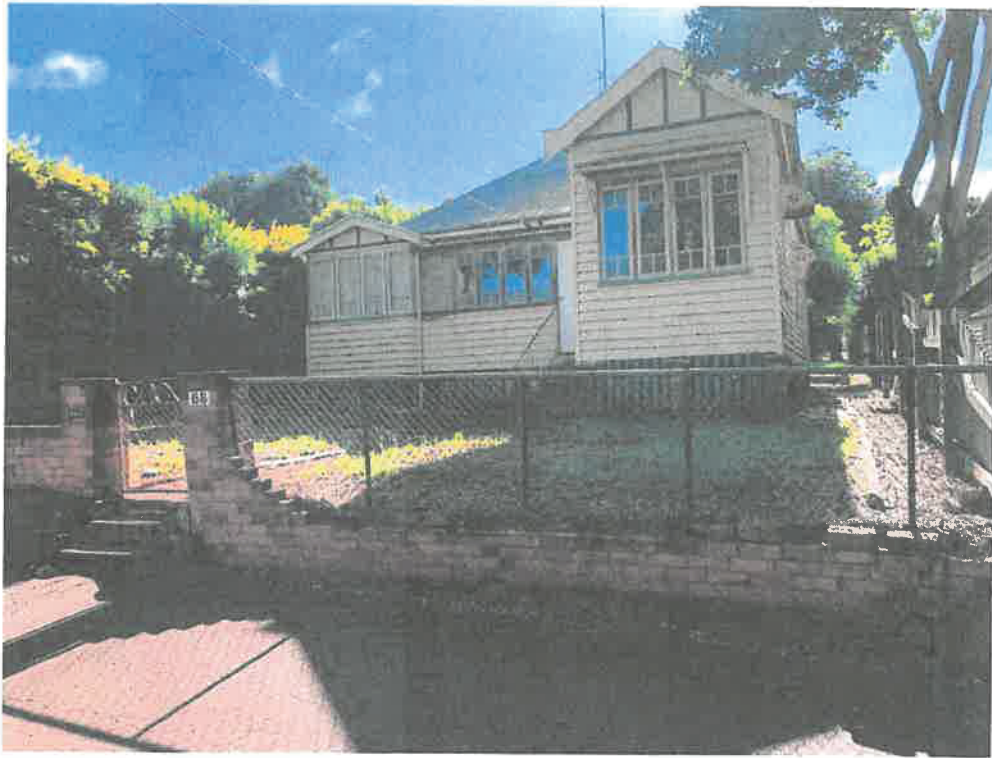
Photo 1 – View from Hume Street of the Residence.

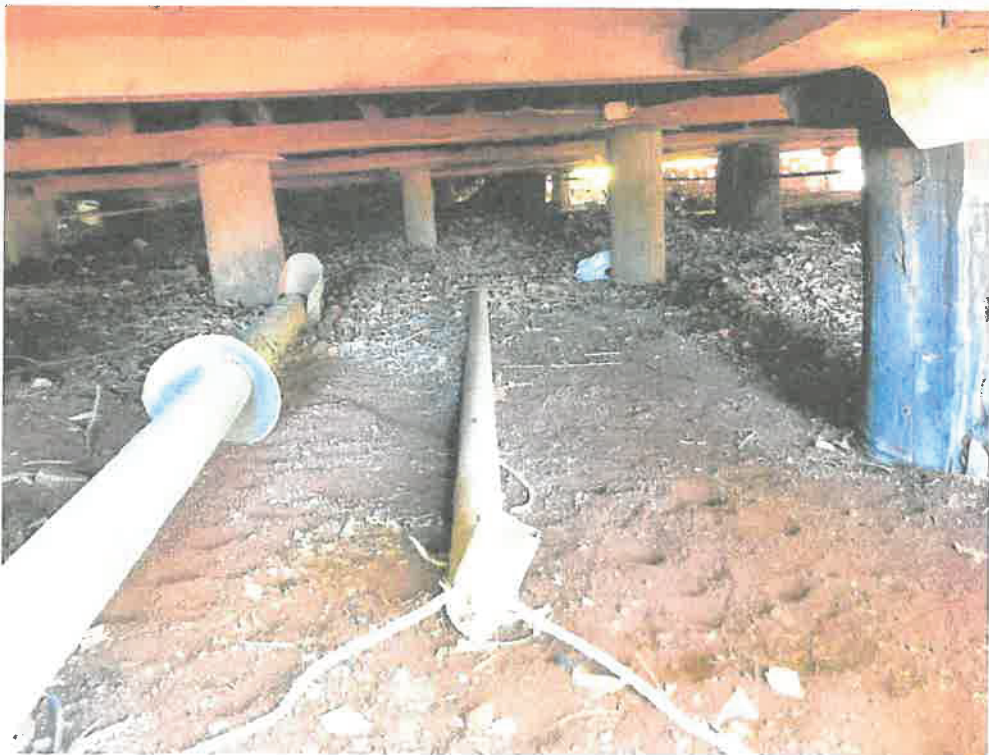
Photo 2 – View of Underfloor

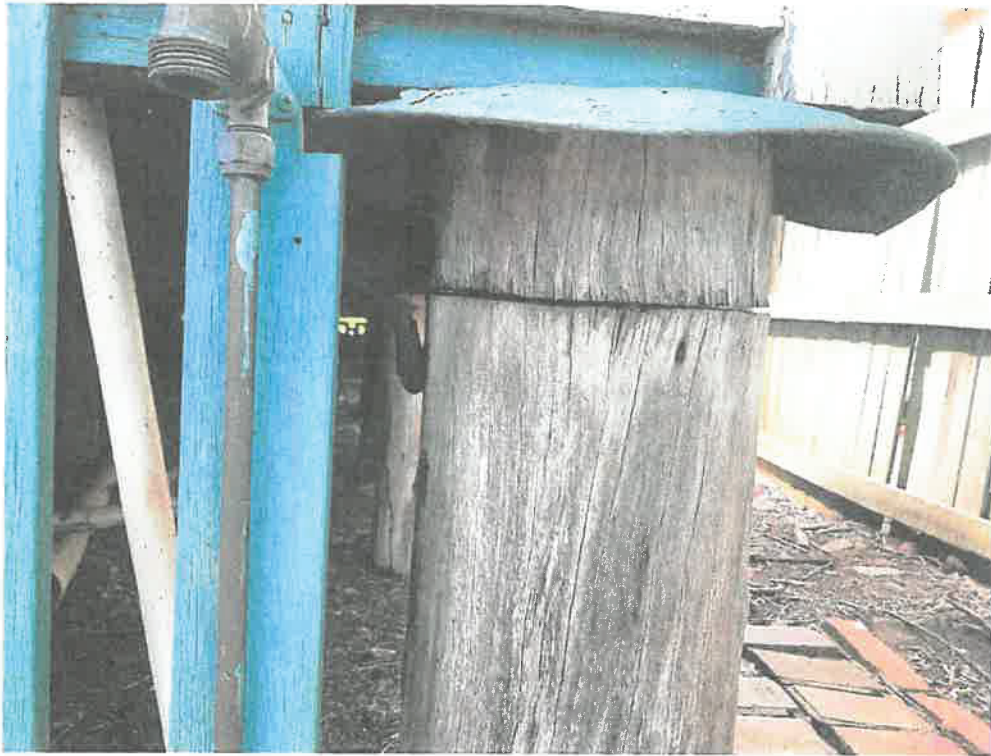
Photo 3 – Stump at front of residence

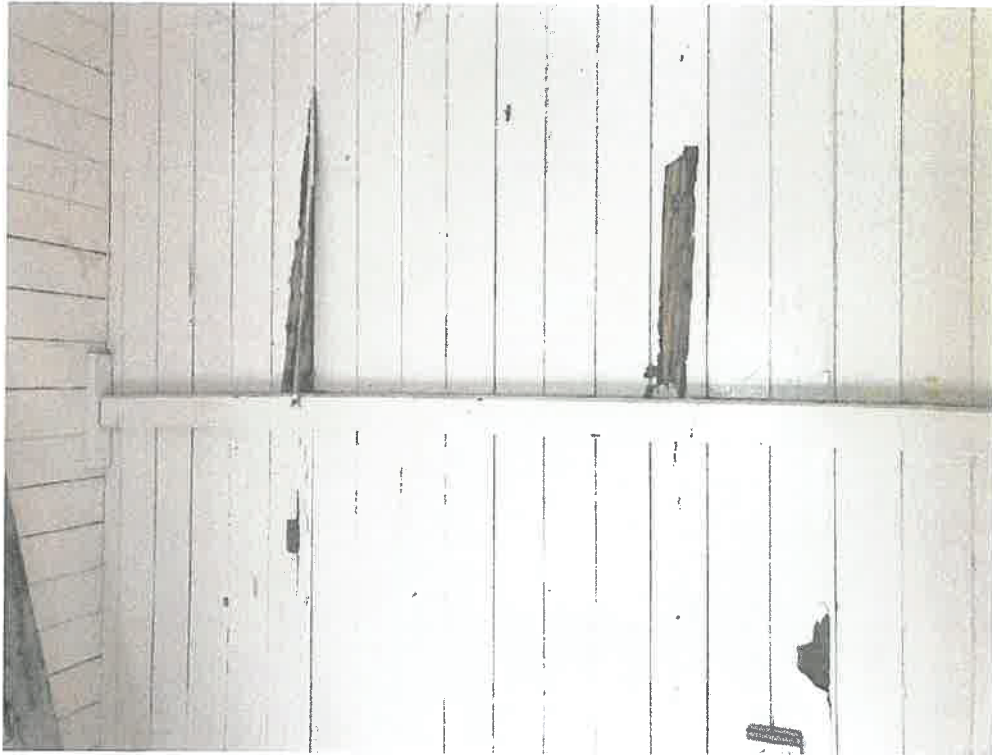
The internal VJ walls and ceiling lining were showing signs of extensive termite damage in all rooms.

Photo 5 – Internal Termite damage to VJ Walls.

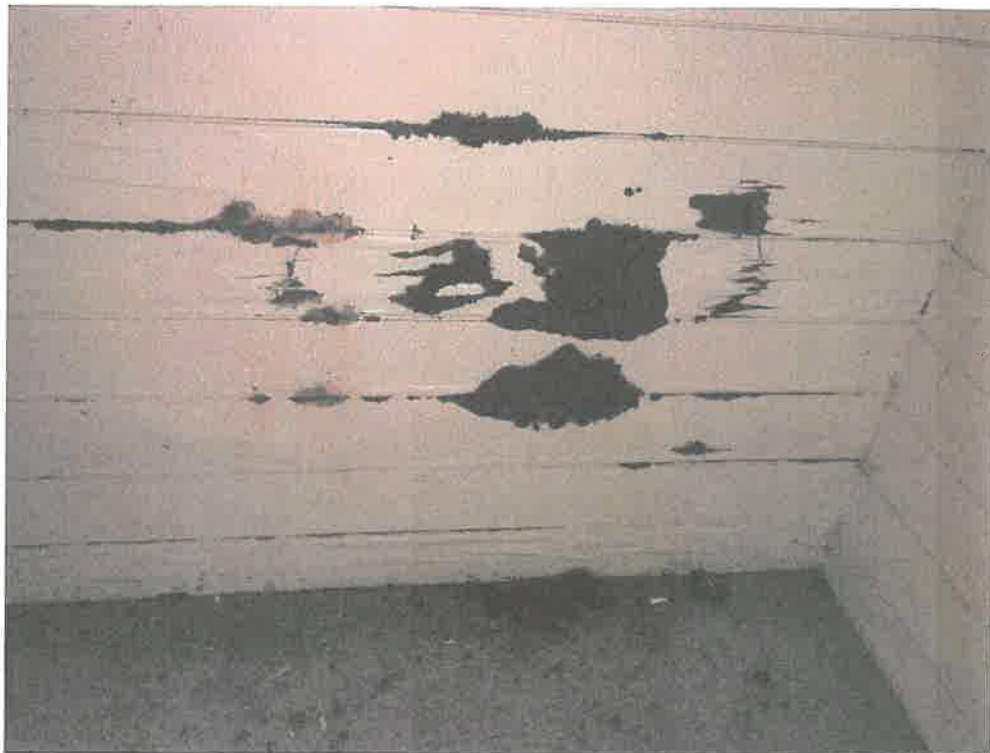
Photo 6 – Termite damage to Internal Walls.

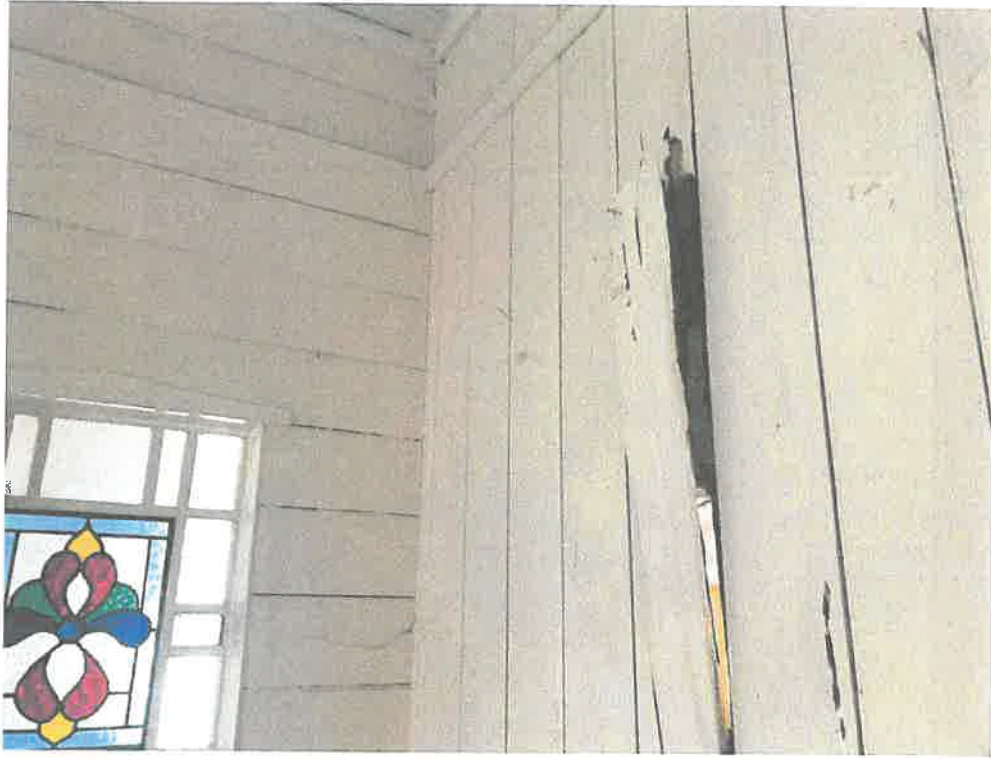
Photo 7 – Further termite damage to Internal Walls

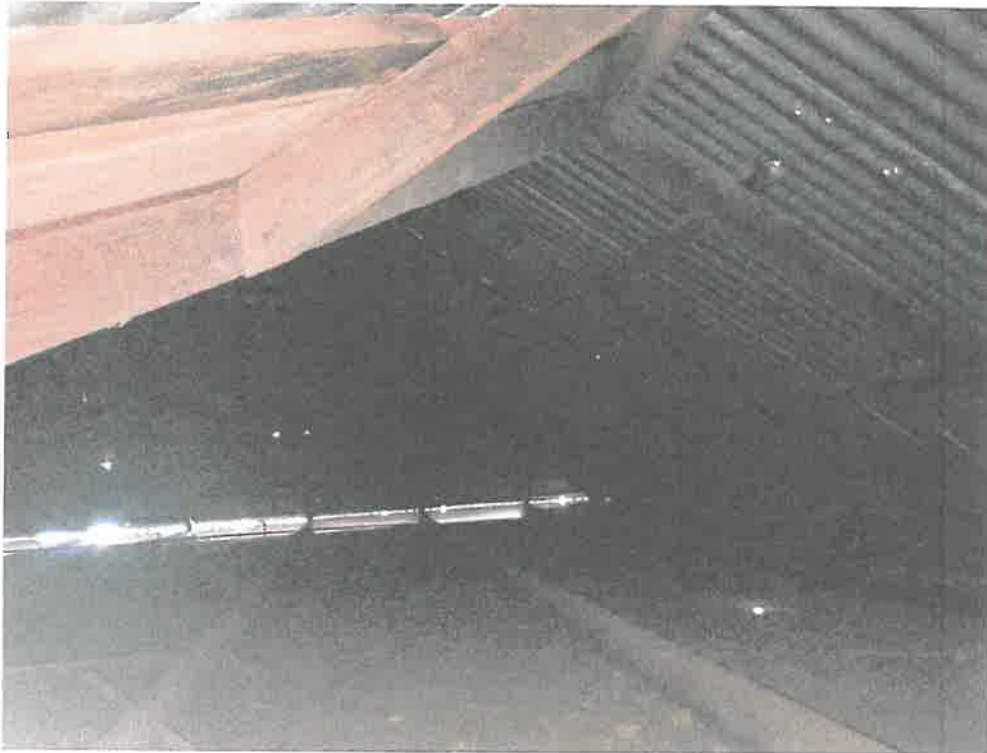
The majority of the lead-head nails holding the roof sheeting were showing signs of lifting and/or being loose. The roof sheeting was showing signs of rust holes and corrosion at the laps. The battens were showing signs of splitting at the nail holes with some battens missing having split completely.

Photo 8 – View of Roof Cavity – Note no underpurlins or strutting to rafters, discontinuous roof battens, rust holes to roof sheeting.
