**PLANS AND DOCUMENTS**  
referred to in the REFERRAL  
AGENCY RESPONSE

PROJECT  
MACKENZIE STREET,  
MOUNT LOFTY - SUBDIVISION

# Weed Management and Rehabilitation Plan

## 2A & 2B Rifle Range Road, Mount Lofty

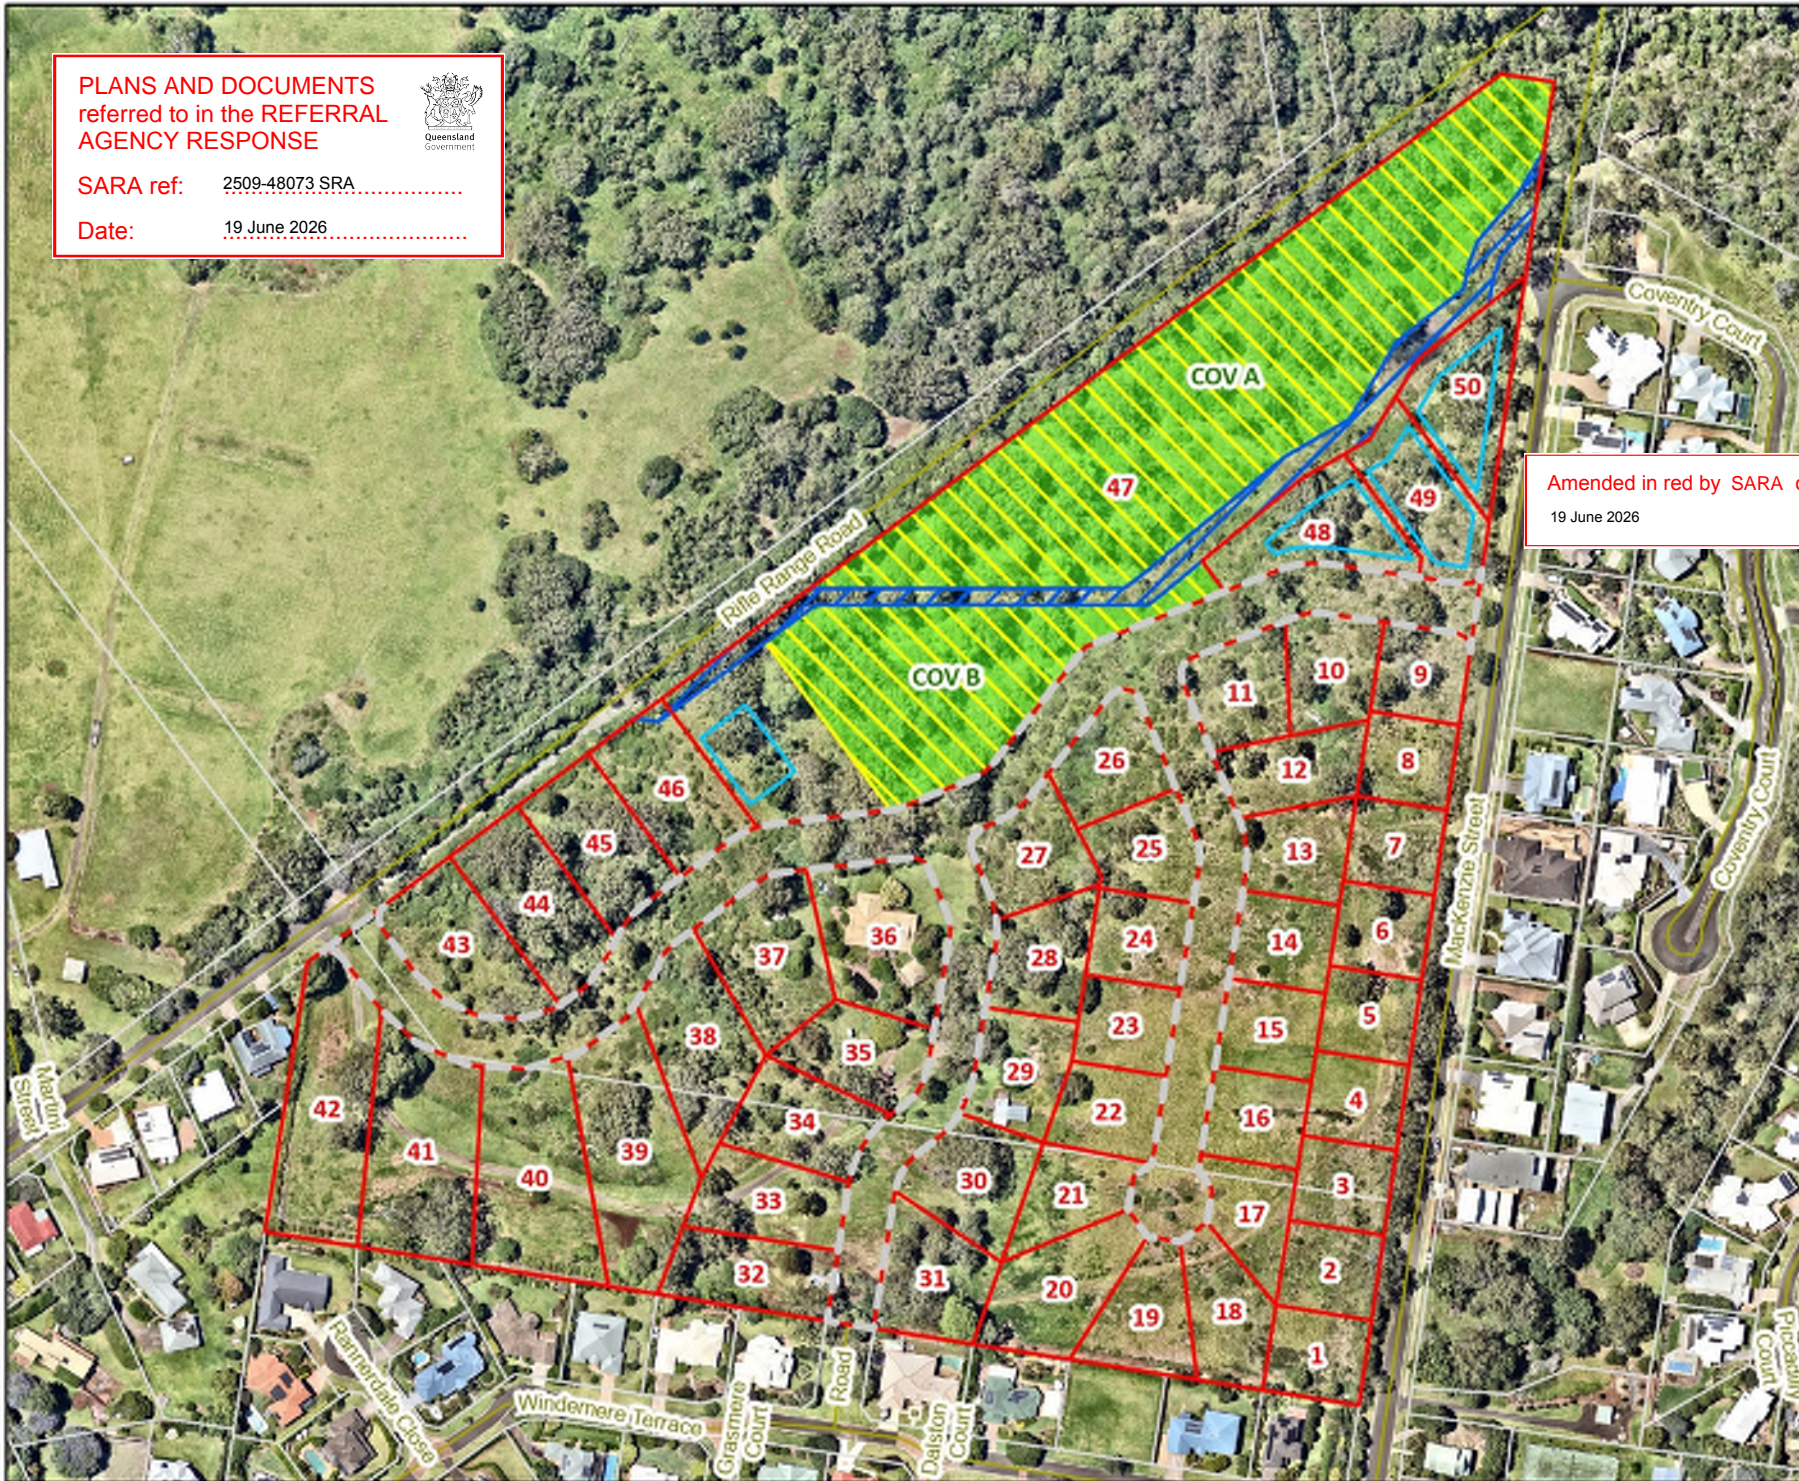
## Figure 2 Proposed Development

Amended in red by SARA on  
19 June 2026

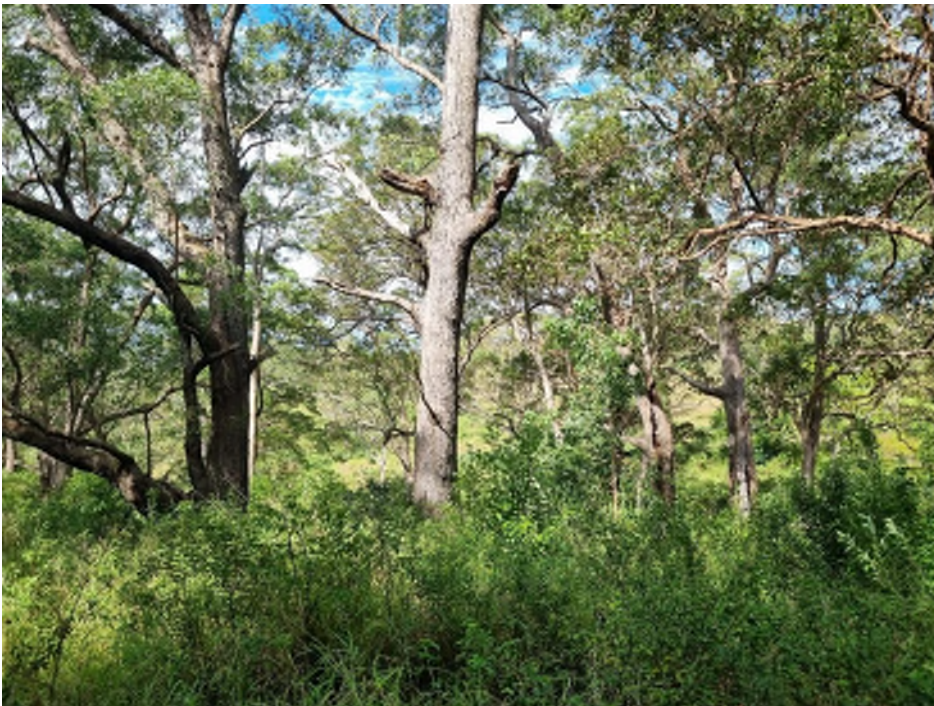
**Photograph 1 VC1- Established White stringybark and Pink bloodwood canopy with Lantana shrub layer and dense grassy groundcover.**

Vegetation Community 1 contained vegetation within the north and western portion of the site. Vegetation Community 1 contained canopy species consistent with RE 12.8.14/12.8.17, with dominant species including Forest red gum (*Eucalyptus tereticornis*) and White stringybark (*Eucalyptus eugenioides*) with associated Grey gum (*Eucalyptus biturbinata*), Pink bloodwood (*Corymbia intermedia*), Sally wattle (*Acacia salicina*), Spotted gum (*Corymbia citriodora* subsp. *variegata*), Blackbutt (*Eucalyptus pilularis*), White mahogany (*Eucalyptus acmenoides*), Brush box (*Lophostemon confertus*) Jacaranda (*Jacaranda mimosifolia*) and *Geijera* sp.. The vegetation community contained multiple large stags. Midstory vegetation was absent within this area.

The shrub layer was dense across this area of the site dominated by invasive species. Lantana (*Lantana camara*) was the dominant species with associated native Coffee bush (*Breynia oblongifolia*) and Native peach (*Trema tomentosa*). Broad-leaved privet (*Ligustrum lucidum*) was present in high densities in association with the northwestern boundary of the site. Other observed species included Wild tobacco (*Solanum mauritianum*).

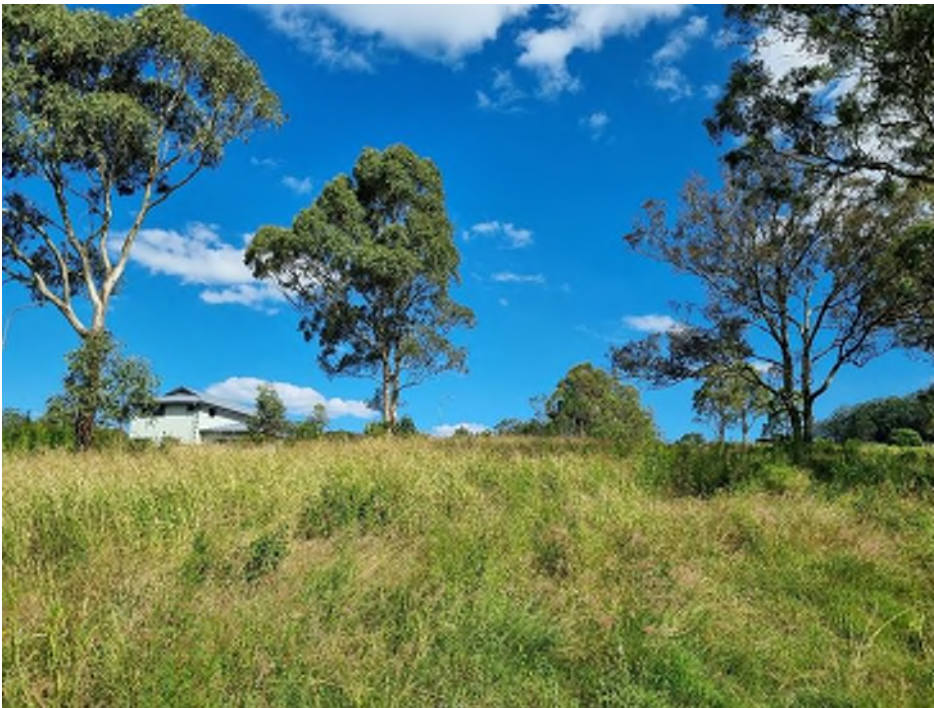
**Photograph 2 VC2- Sparse native canopy values with species aligning with RE 12.8.14/12.8.17 with a grassy understory.**

Vegetation community 2 contained canopy species aligning with RE 12.8.14/12.8.17, with dominant species including Forest red gum with associated Yellow box (*Eucalyptus melliodora*), Narrow-leaved ironbark (*Eucalyptus crebra*) and Pink bloodwood. Canopy vegetation values were sparser across this vegetation community in comparison to VC1. Midstory vegetation was absent within this area.

The shrub layer was sparse with isolated dense patches of Lantana through the area.

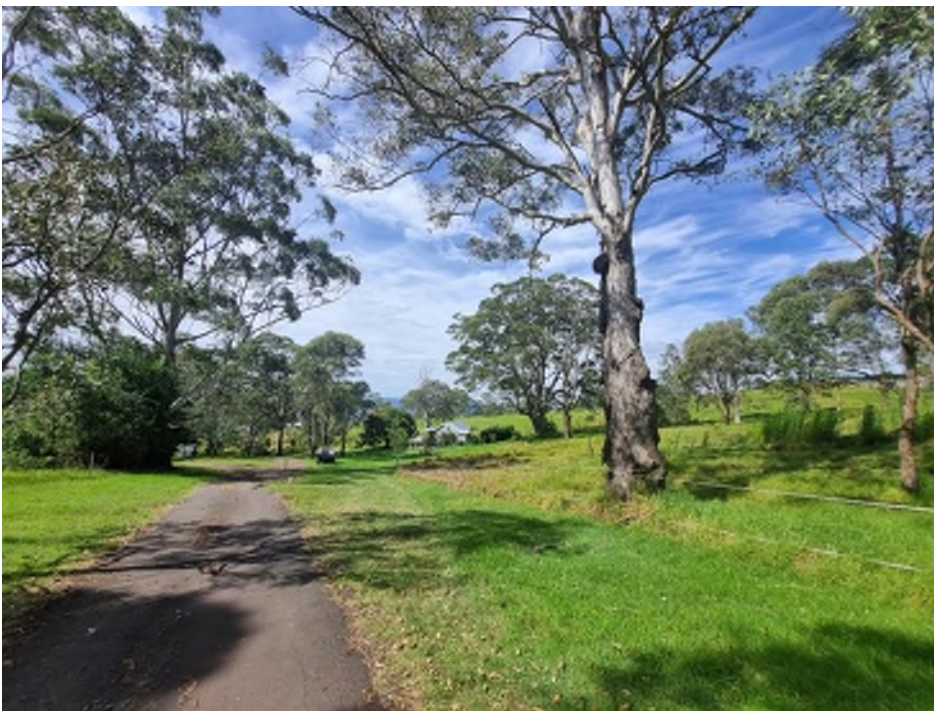
**Photograph 3 VC3- Forest red gum canopy and maintained grassy understory.**

Canopy vegetation within VC3 was sparse with the canopy containing species aligning with RE 12.8.14/12.8.17 dominated by Forest red gum, with associated White stringybark, Grey gum, Pink bloodwood, Sydney blue gum, Rough-barked apple, Broad-leaved apple and Bunya pine (*Araucaria bidwillii*). Planted canopy species around the existing dwelling included Giant sequoia (*Sequoiadendron giganteum*), Cadaghi (*Corymbia torelliana*) and Jacaranda (*Jacaranda mimosifolia*). The subcanopy was dominated by Sally wattle with associated Flame tree (*Brachychiton acerifolius*), Ficus sp., Brush box and Silky oak (*Grevillea robusta*). The vegetation community contained multiple large stags.

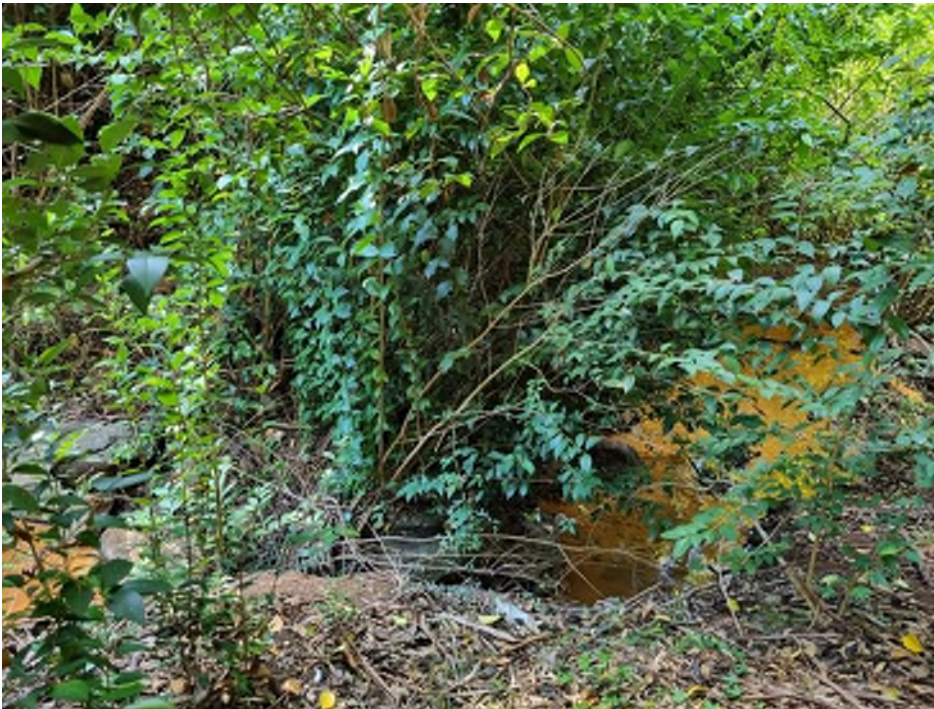
**Photograph 4 VC4- Broad-leaved privet dominated area in association with the unmapped water feature onsite.**

This area contained a dense shrub layer of Broad-leaved privet with an absent groundcover.
