# ARBORICULTURAL IMPACT ASSESSMENT

**185 POSTLE STREET,  
MOUNT RASCAL**

**APRIL 2026**

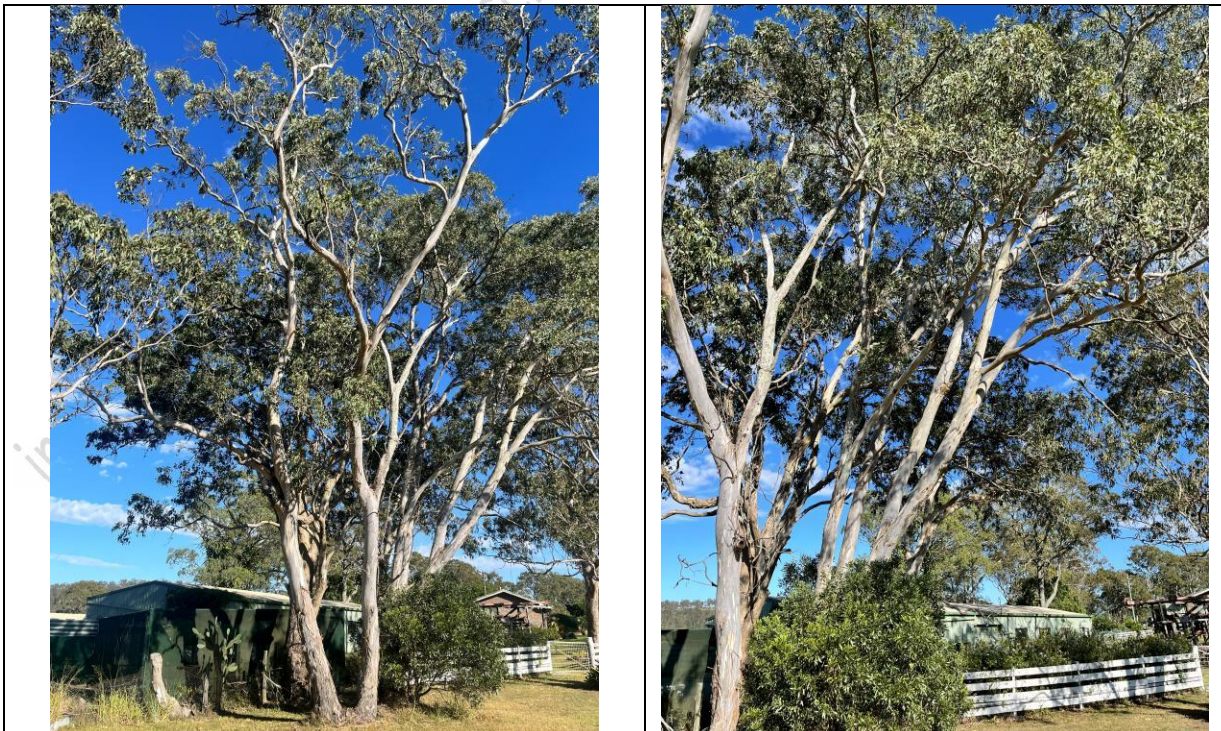
T1

The following images encapsulate the subject tree's growing environment, canopy morphology, branching arrangements, site characteristics and/or critical area(s) of interest from the start of works to the end of works.

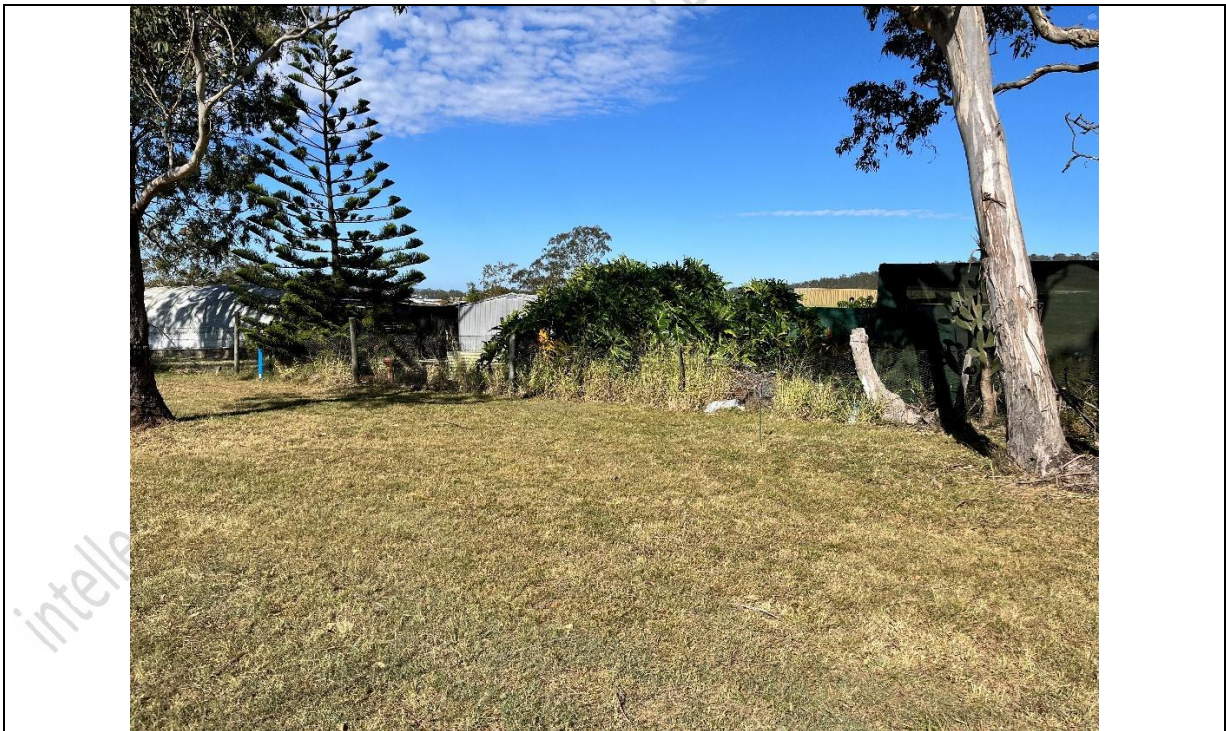
Space between T1 (Right) and T4 (Left) for proposed driveway

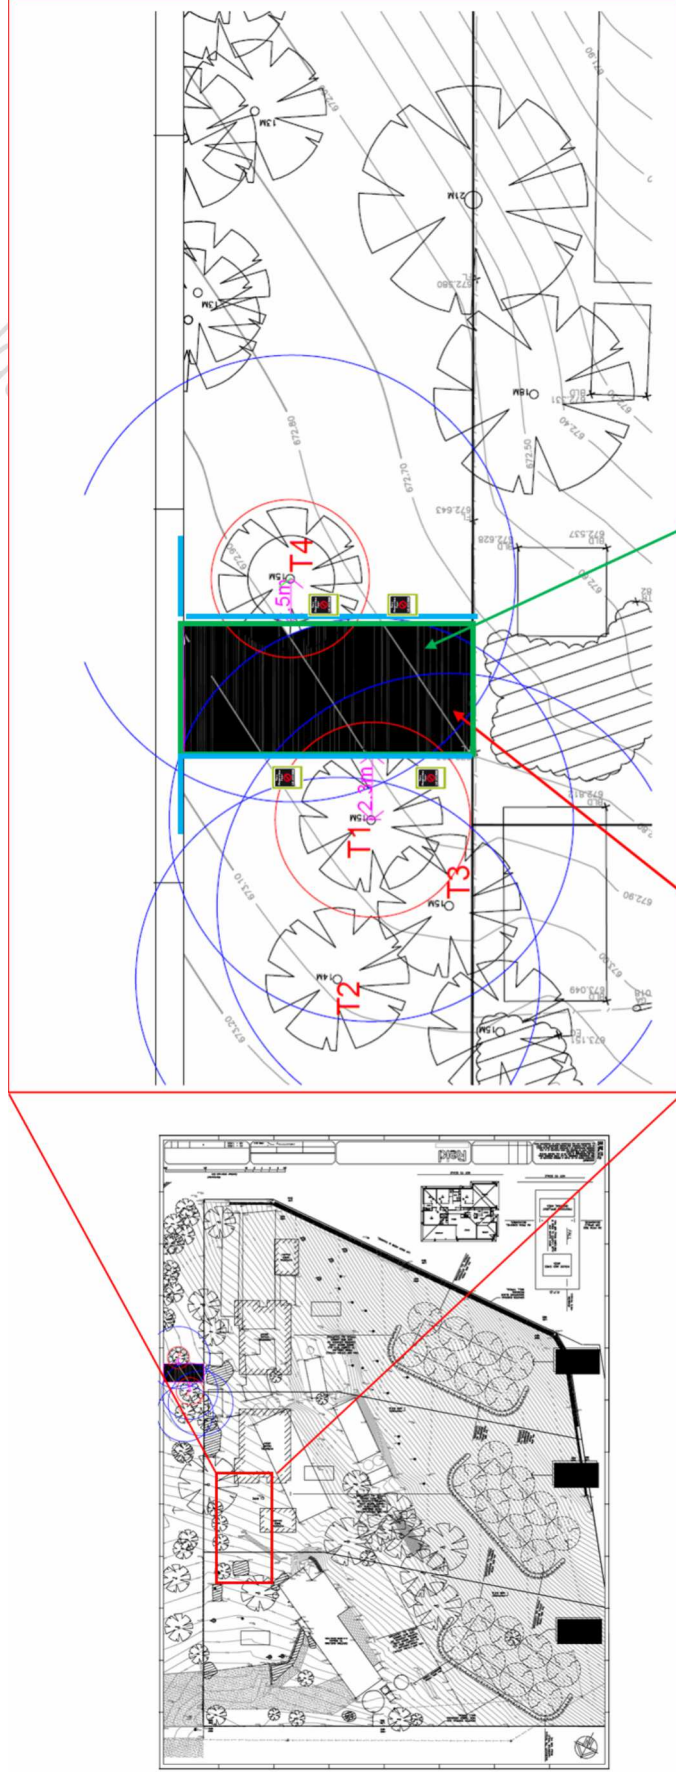
04.7 tree protection plan (not to scale).

Excavation for driveway crosscover to be limited to no greater than 150mm depth. Excavation undertaken under Project Arborist supervision.

Potential 5m wide crosscover location – utilised for impact assessment purposes

- The driveway crossover is to be constructed on the existing soil grade where appropriate and shall not be significantly lowered beyond one hundred & fifty (150) millimeters (mm) or significantly raised beyond three hundred (300) millimeters (mm) without prior design outcomes documented and arboriculturally certified by Treescience. Additionally, if possible, the pathway is to be graded toward the root zone area of a tree so excess water runoff is harvested for numerous health benefits to trees and soil.

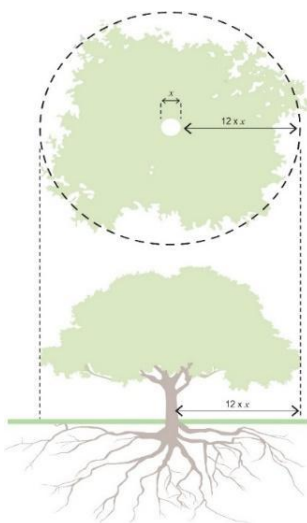
The area equivalent to the NRZ/SRZ encroachment shall be incorporated into the TPZ.

The NRZ for individual trees is calculated based on trunk (stem) diameter (DSH), measured at 1.4 metres up from ground level.

The radius of the NRZ is calculated by multiplying the tree’s DBH by 12.

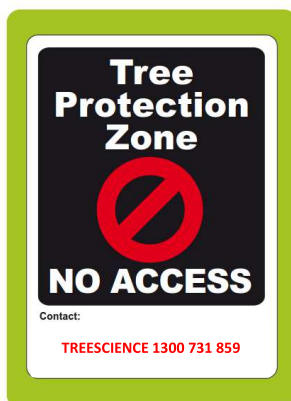
Below is an example of a tree protection fence sign design.

The TPZ sign shall be repeated at 15 metre intervals or closer where the TPZ fence changes direction. The signage shall be installed prior to the commencement of works on-site and shall be maintained in good condition for the duration of the development period.
