REPORT TITLE	Development Application – Preliminary Approval – Building Work (Planning Scheme Works) – Demolition of Neighbourhood Character Dwelling located at 68 Hume Street, NORTH TOOWOOMBA QLD 4350
AUTHOR	Senior Planner (Geoff Broadbent)
Application No.	PSW/2020/5933

To consider a Development Application for a Preliminary Approval for Building Work (Planning Scheme Works) – Demolition of Neighbourhood Character Dwelling located at 68 Hume Street, NORTH TOOWOOMBA QLD 4350.

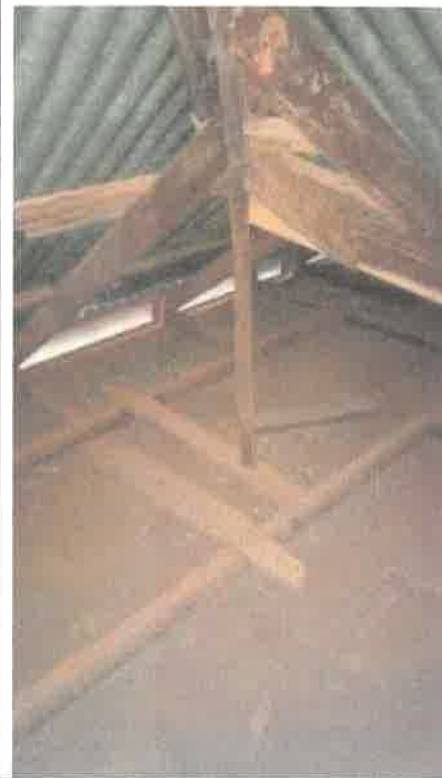
**ROOF 2**

The majority of the lead-head nails holding the roof sheeting were showing signs of lifting and/or being loose. The roof sheeting was showing signs of rust holes and corrosion at the laps. The battens were showing signs of splitting at the nail holes with some battens missing having split completely.

1. The entire roof sheeting, fixing and battens will need to be replaced and should be carried out to current standards.
2. The roof framing will require tie-down upgrading to comply with current standards if certification is to be provided.
3. The VJ wall sheeting will have to be replaced where termite damaged to achieve adequate wind bracing.
4. Any floor boards damaged by termites will have to be replaced to be considered structurally adequate.
5. All stumps will need to be replaced and tie-down bolts added to be considered structurally adequate. The design of the replacement stumps should be to current standards if certification is to be provided.
6. The isolated garage is considered should be completely replaced.

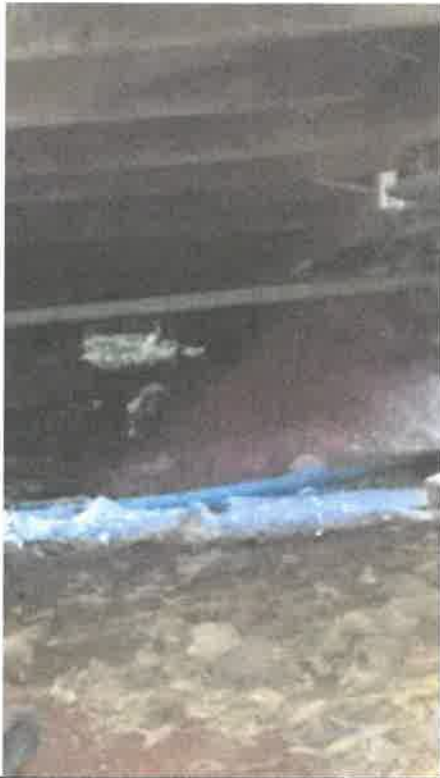
**UNDER FLOOR 1**

The floor still had various coverings in place so a full damage survey could not be carried out. Observations from under the floor showed isolated areas of damage near the stumps where the termites had breached the steel capping.

The majority of the interior stumps were showing signs of dry rot and age-related splitting.

A limited number of internal stumps were also showing termite damage.

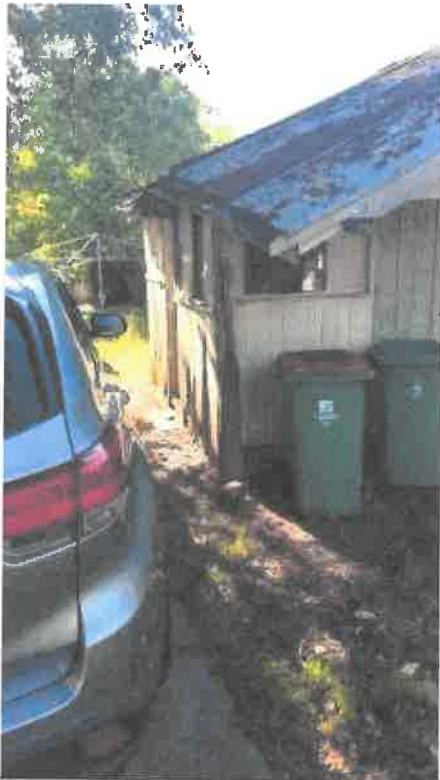
**GARAGE 1**

The isolated garage is considered beyond repair.

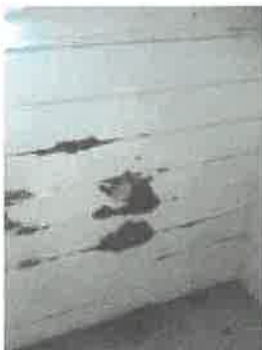
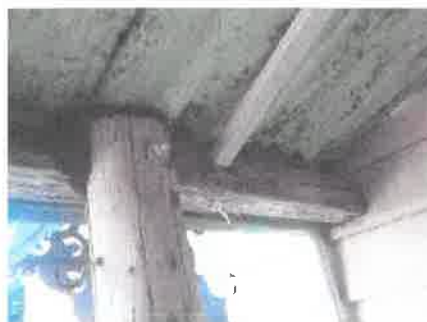
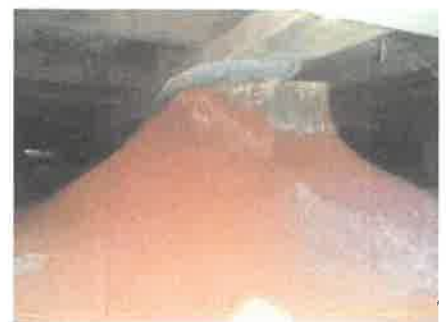
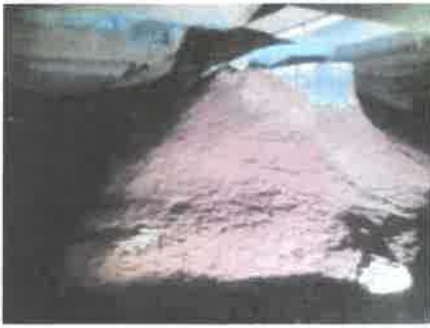
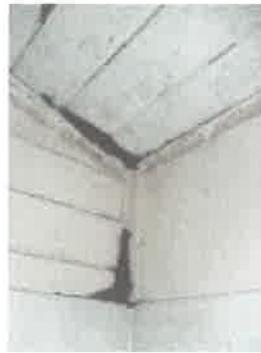
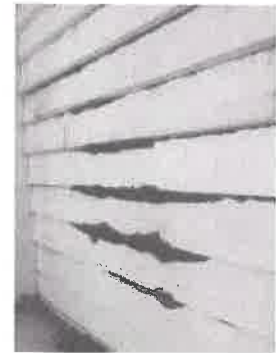
The genus or species has been positively identified as: **Coptotermes species - Activity found throughout home and under home.**

Details (include location of live termites found and any recommendation for further expert advice): **Interior - Extensive internal activity in VJ walls. Exterior - Extensive activity in chamfers and timber posts. Roof Void - Activity in roofing timbers. Subfloor - Termite activity throughout floor and floor framing and timber piers.**

Is a Subterranean Termite Management Proposal recommended? **No - The home is past treatment.**

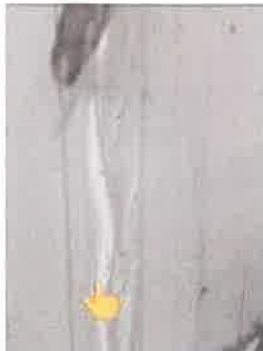
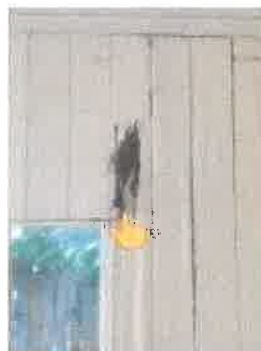
Was evidence of termite workings or damage found? **Yes - see Details below, Clauses A.3 and A.8 - Termite workings found in timber walls.**

The extent of any visible damage appears: **Widespread - see Details and Recommendation below - Damage found throughout VJ walls.**

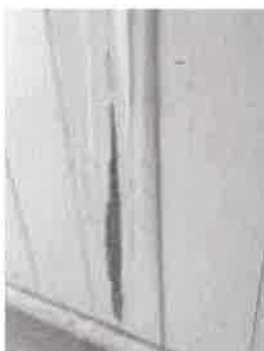
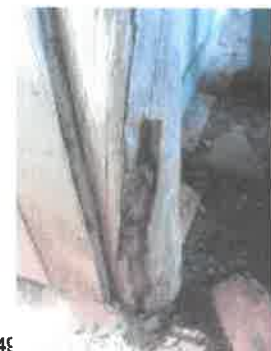
**Interior - Termite damage throughout all VJ walls. Subfloor Grounds - Termite evidence found throughout exterior areas of yard. Out Buildings - Termite evidence in timber piers.**

*RECOMMENDATION Where evidence of damage to building timbers exists, competent advice (e.g. from a licensed and practicing building contractor) should be obtained to determine the extent of any structural damage and as to the need or otherwise for rectification or repair work. See also Item 3.1.5 'Frequency of Future Inspections' recommendation.*

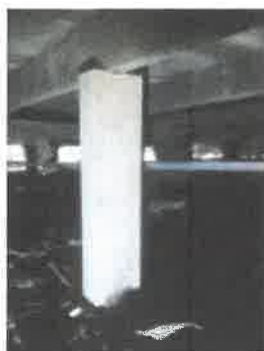
Was evidence of bridging or breaching found? **Yes - see Details below, Clauses A.7 and A.8**

Include any visible evidence of bridging or breaching or slab edges obstructed by: **Other (explain below) - Timber prop under home bridges termite shielding.**
